Documentation for  
Grease and Odor Control Project  
Using

**PROJECT** - Grease and Odor Control in Lake Dallas, TX

**LOCATION** – Lift Station #6, 7 & 8

Re: Project Documentation for Grease Control Using Micro-Solve® Solubilizer-Demulsifier/Bacteria Accelerator.

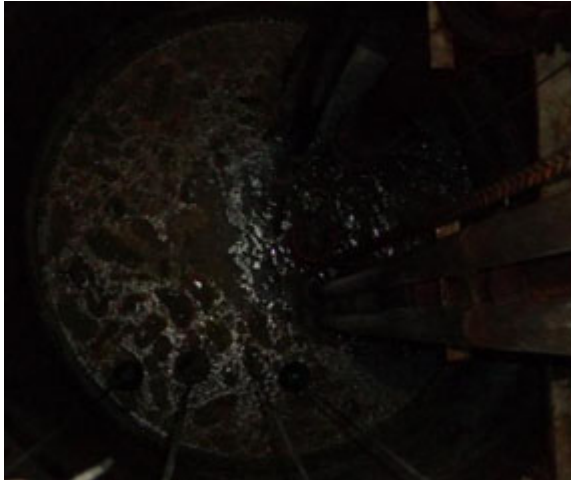
April 2<sup>nd</sup>

The above photos were taken of the wet well at Lift Station #6 in Lake Dallas, Texas.

Issues: This wet well is located at the most outer lying lift station on this collection line. This wet well is said to have the grease “fished” out of it on a weekly basis. The collection line that had a camera is confirmed to be the incoming line to this area, so we are considering alternating applications from the nearest upstream manhole to the wet well every other week. Mr. Don Johnson confirmed that the large grease chunks were from the incoming line that they had jetted out not too long ago.

**At first glance when comparing to the previous week it appears to have slightly more grease in the area. However the consistency of the grease is lighter and fluffier with very little density to the mass. This creates a melting effect on the larger chunks and the grease has actually started to spread out or dissipate. The floats are still free of grease and any fresh grease that has come in to the area is still not solidifying or causing any problems in the station after 7 weeks with no maintenance.**

Dosage: 5 gallons per week alternating between the upstream manhole and the wet well at LS #6.

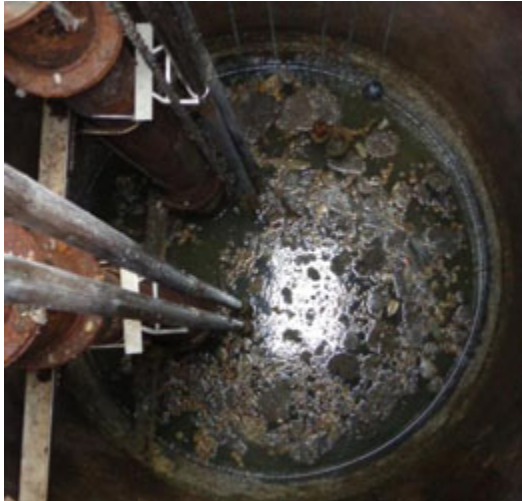
April 2<sup>nd</sup>

The above photos were taken of the wet well at Lift Station #7 in Lake Dallas, Texas.

Issues: Don confirmed that they are cleaning the grease out of this wet well on a weekly basis and that there are other areas tying into this lift station that account for approximately 50% of the flow entering the area.

**This lift station continues to be maintained at the same conditions as previous weeks. There is fresh grease coming into the area but it is being taken care of, not solidifying, or causing any issues with the lift station. Since we are only treating half of the water that is coming into this lift station we can assume that the additional grease that is collecting is coming from other areas. Even with only treating half the water Micro-Solve® has kept the grease from causing any problems after 7 weeks with no additional maintenance being preformed.**

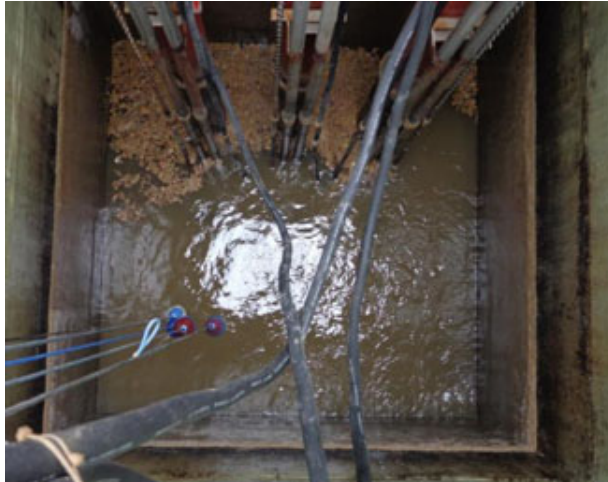
March 26<sup>th</sup>

The above photos were taken of the wet well at Lift Station #8 in Lake Dallas, Texas.

Don confirmed that they are cleaning the grease out of this wet well on a weekly basis and that there are other areas tying into this lift station. There is currently an odor concern at this wet well and carbon filters are in place, but rarely changed. There is also some calcified grease that has collected around the rim of the well and the pipe leading up the left side of the photos.

**As you can see there continues to have fresh grease coming into the area but it is not solidifying or causing problems and there are no large chunks of grease that have collected. This Lift Station is currently at a maintenance level.**
