Documentation for  
Grease and Odor Control Project  
using

**PROJECT** - Grease Control in Somerset, TX  
**CLIENT** – San Antonio River Authority  
**LOCATION** – K Street Lift Station

Re: Project Documentation for Grease Control Using Micro-Solve Solubilizer-Demulsifier/Bacteria Accelerator

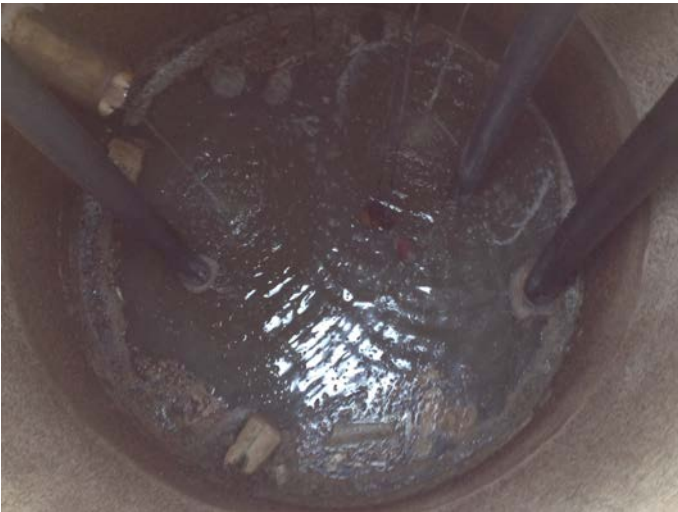
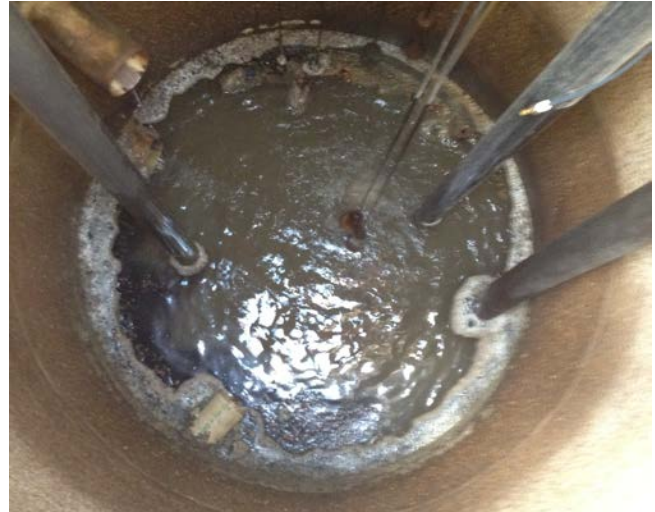
May 30, 2012 – First Application

The above photos were taken of the wet well at the K Street Lift Station in Somerset, Texas on May 2<sup>nd</sup> (left) and May 30<sup>th</sup> (right).

Even though the lift station appears to be vacced out regularly, in both of these photos we can visually see the calcified grease that has collected around the walls, floats and pipes that are in contact with the water. In most experiences if there is a calcified build-up that is visible on or above the water line, then there will also be a build up of debris and sludge below the surface of the water.

Issues: This area is being fed a large amount of grease from an upstream community center. The lift station is said to need vaccing every 3 months. The lift station is having issues setting off alarms, which in turn is requiring an on-call employee to tend to the emergency. Mr. Ploetz confirmed that grease is getting caught in the pump and is the primary cause of the issue.

We have also agreed to treat the downstream collection line to clean out any grease that has built up in the collection line. After the initial camera inspection of that line we realized that the grease in the line was minimal, so we are going to monitor the WWTP's master lift station for progress. That lift station is said to be over 2 miles downstream.

Dosage: 5 gallons per week in the lift station. 5 gallons per week in the downstream collection line.

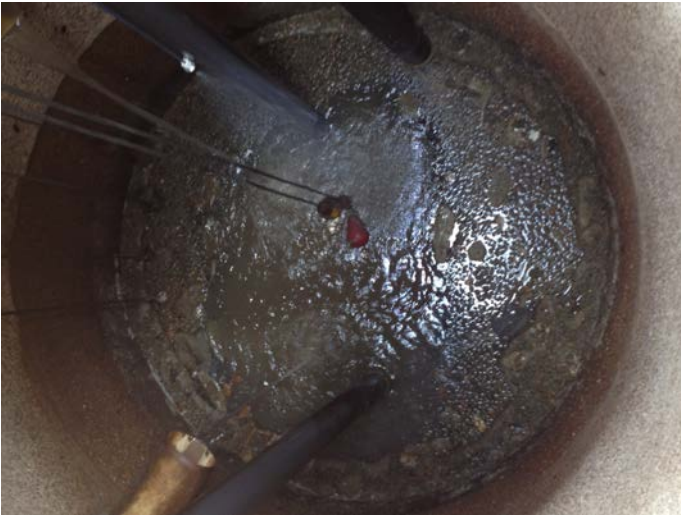
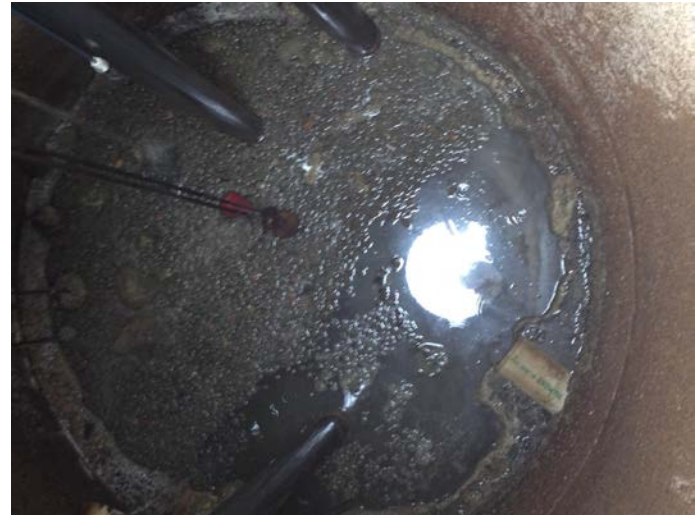
June 14, 2013 and June 21, 2013

The above photos were taken of the wet well at the K Street Lift Station in Somerset, Texas on June 14<sup>th</sup> (left) and June 21<sup>st</sup> (right).

At this point we have been treating the area for 2 and 3 weeks and it can be seen that there is a large amount of grease chunks that are starting to appear on the surface. Also, the lip around the wall is beginning to develop large craters that are now holding water. Micro-Solve<sup>®</sup> has begun to erode the calcified lip around the wet well and we can also notice that the fresh grease that is entering the area is being digested by the facultative aerobes and anaerobes. The floats are staying clean and you can see from one week to the next the incoming pipe on the lower right hand corner becomes visible.

Dosage: 5 gallons per week in the lift station. 5 gallons per week in the downstream collection line.

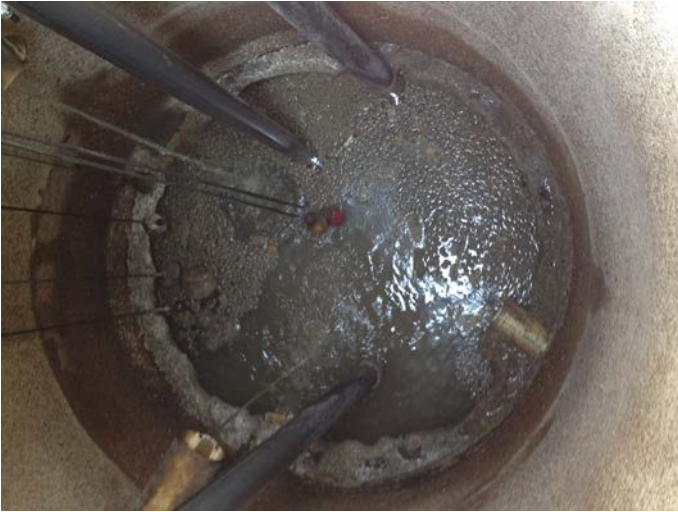
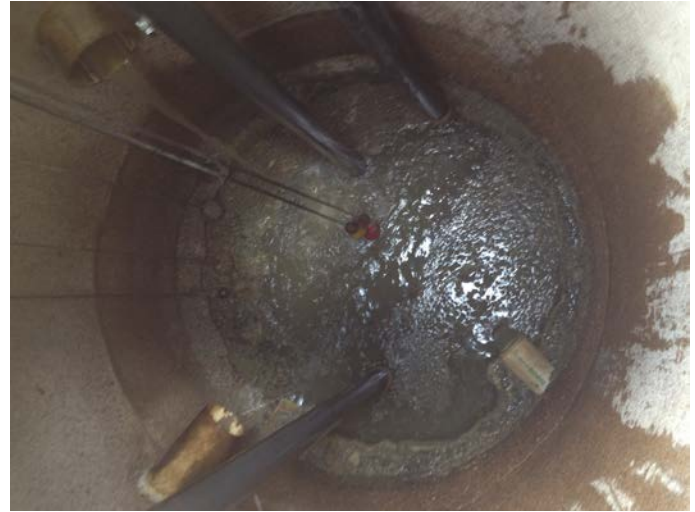
July 9, 2012 and July 19, 2012

The above photos were taken of the wet well at the K Street Lift Station in Somerset, Texas on July 9<sup>th</sup> (left) and July 19<sup>th</sup> (right).

At this point we have been treating the area for 6 and 7 weeks, respectively. In these two photos, the lips around the pipes are gone and we can begin to see that there is an incoming line directly under the pipe on the left hand corner at water level. In the second photo the lip around the wall on the top of the photo has fallen off and is floating near the lower group of floats.

Dosage: 5 gallons per week in the lift station.

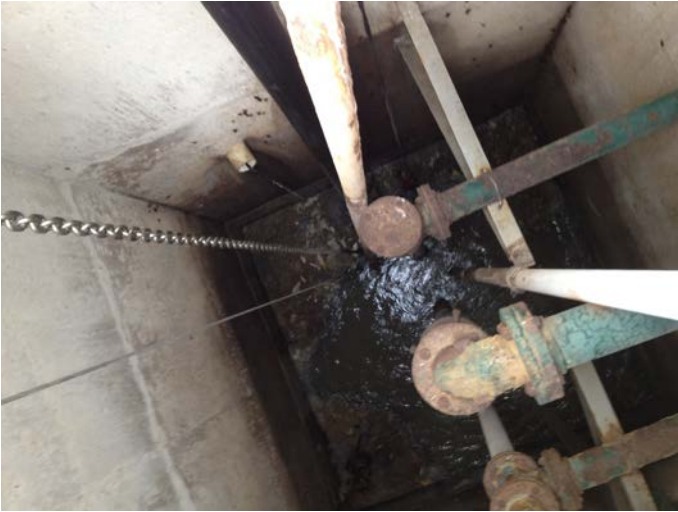
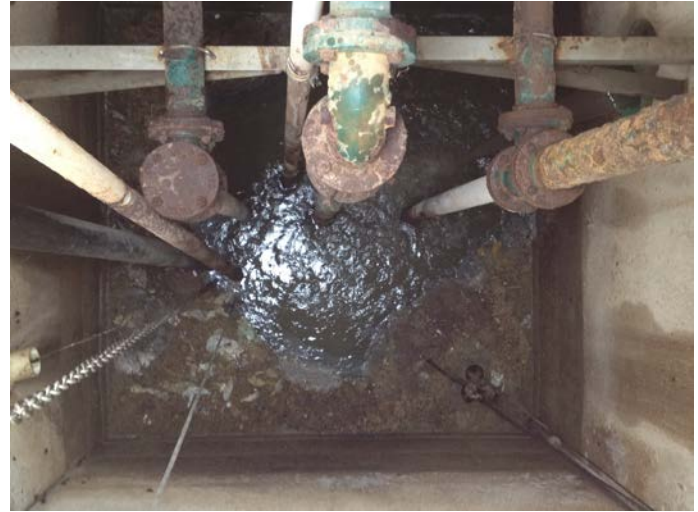
June 21, 2012 and July 9, 2012

The above photos were taken at the Somerset Wastewater Treatment Plant's Master Lift Station in Somerset, Texas on June 21<sup>st</sup> (left) and July 19<sup>th</sup> (right).

This lift station wasn't being treated directly, but it was the nearest downstream lift station, over 2 miles downstream. In the picture on the right you can see that a good portion of the grease has a light brown color and a light fluffy texture. A positive sign that the Micro-Solve<sup>®</sup> is working its way to the plant and the facultative bacteria are beginning to thrive. As a result of a TCEQ inspection, Ricky Carrasco scheduled a vaccing out. Ted's crew and Ricky both confirmed that the lift station typically had a lot more grease and needed to be cleaned out every three months. Ricky also confirmed that 'gum ball' sized grease chunks that he typically fished-out of the clarifier were now only the size of pebbles.

Dosage: 5 gallons per week in the 'K' Street Lift Station that is located 2 miles upstream.

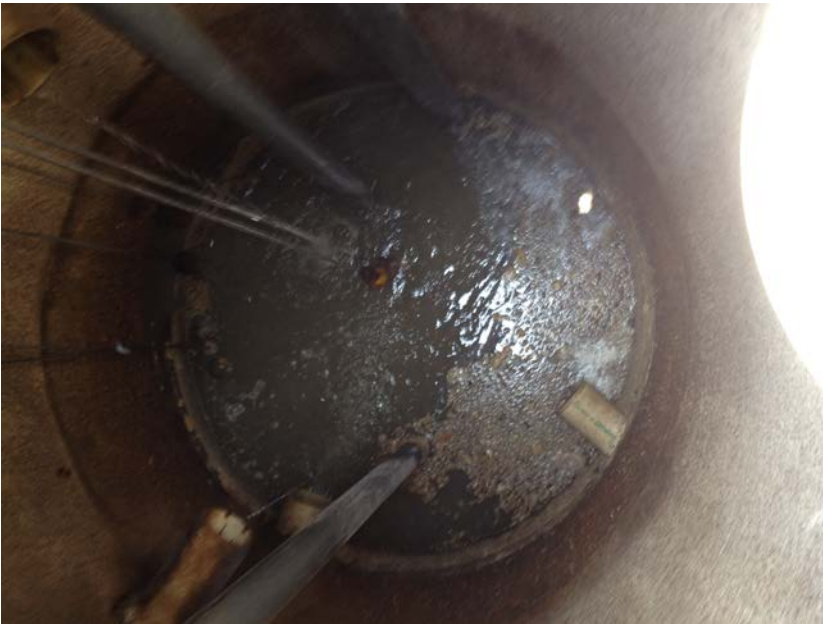
August 23, 2012

The above photo was taken of the wet well at the K Street Lift Station in Somerset, Texas on August 23, 2012.

During the last month of the pilot we noticed that all the pipe-shaped 'logs' of grease that were dislodged from the inside of the submerged pipes were nearly 100% gone. The grease lip around the wall that had previously built up, and was not even able to be removed by the vac truck, is at least 80% - 90% gone. The grease around the incoming pipe is fresh, soft and already partially digested. It has no properties to bind itself to any floats, pumps or pipes and cause issues associated with grease build up.

Mr. Jim Doersam came to visit the lift station and confirmed with Mr. Terry Ploetz that the lift station does typically develop a grease cake across the top and that it typically needs to be vacced-out every three months. Mr. Ploetz cameraed to the downstream collection line and confirmed that none of the grease had resolidified downstream.

Dosage: 3 gallons per week maintenance.
