Documentation for  
Grease and Odor Control Project  
using

**PROJECT** - Grease Control in Somerset, TX  
**CLIENT** – San Antonio River Authority  
**LOCATION** – K Street Lift Station

Re: Project Documentation for Grease Control Using Micro-Solve Solubilizer-Demulsifier/Bacteria Accelerator

This reports purpose is to document the progress of Micro-Solve at the 'K' Street Lift Station between the dates of May 30, 2012 and August 23, 2012.

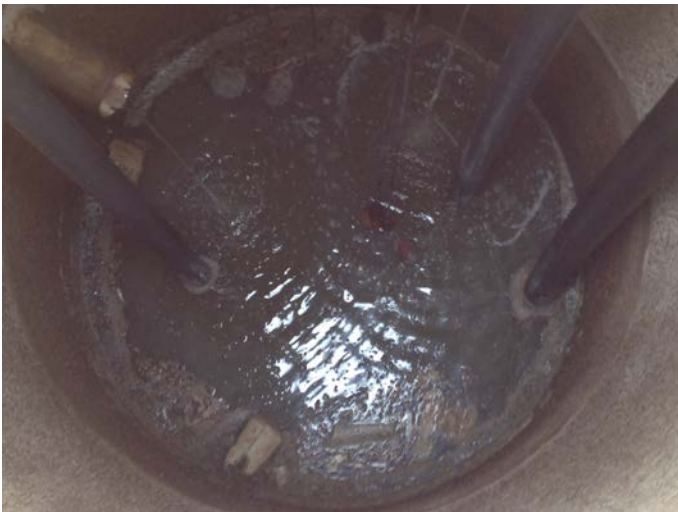
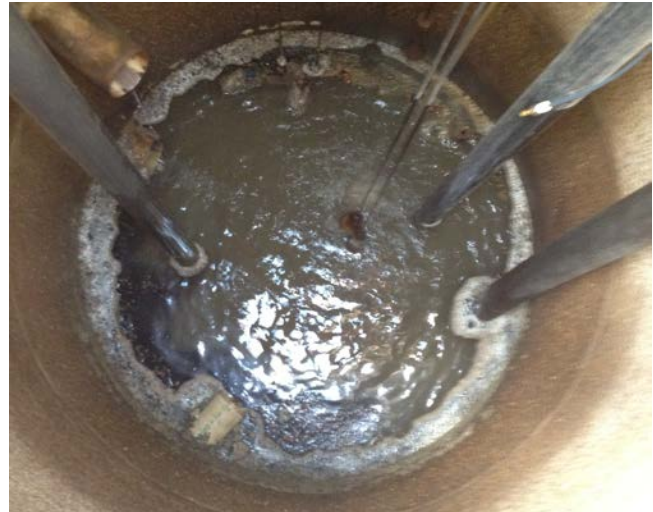
May 30, 2012 – First Application

The above photos were taken of the wet well at the K Street Lift Station in Somerset, Texas on May 2<sup>nd</sup> (left) and May 30<sup>th</sup> (right).

Even though the lift station appears to be vacced out regularly, in both of these photos we can visually see the calcified grease that has collected around the walls, floats and pipes that are in contact with the water. In most experiences if there is a calcified build-up that is visible on or above the water line, then there will also be a build up of debris and sludge below the surface of the water.

Issues: This area is being fed a large amount of grease from an upstream community center. The lift station is said to need vaccing every 3 months. The lift station is having issues setting off alarms, which in turn is requiring an on-call employee to tend to the emergency. Mr. Ploetz confirmed that grease is getting caught in the pump and is the primary cause of the issue.

Dosage: 5 gallons per week in the lift station. 5 gallons per week in the downstream collection line.

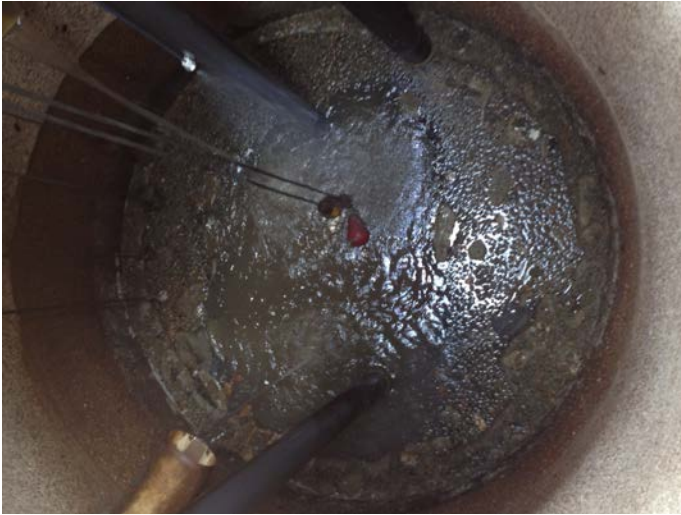
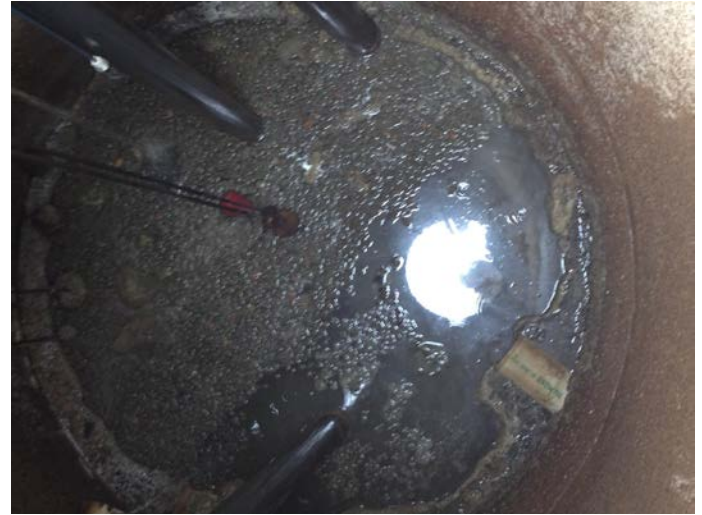
June 14, 2013 and June 21, 2013

The above photos were taken of the wet well at the K Street Lift Station in Somerset, Texas on June 14<sup>th</sup> (left) and June 21<sup>st</sup> (right).

At this point we have been treating the area for 2 and 3 weeks and it can be seen that there is a large amount of grease chunks that are starting to appear on the surface. Also, the lip around the wall is beginning to develop large craters that are now holding water. Micro-Solve has begun to erode the calcified lip around the wet well and we can also notice that the fresh grease that is entering the area is being digested by the facultative aerobes and anaerobes. The floats are staying clean and you can see from one week to the next the incoming pipe on the lower right hand corner becomes visible.

Dosage: 5 gallons per week in the lift station. 5 gallons per week in the downstream collection line.

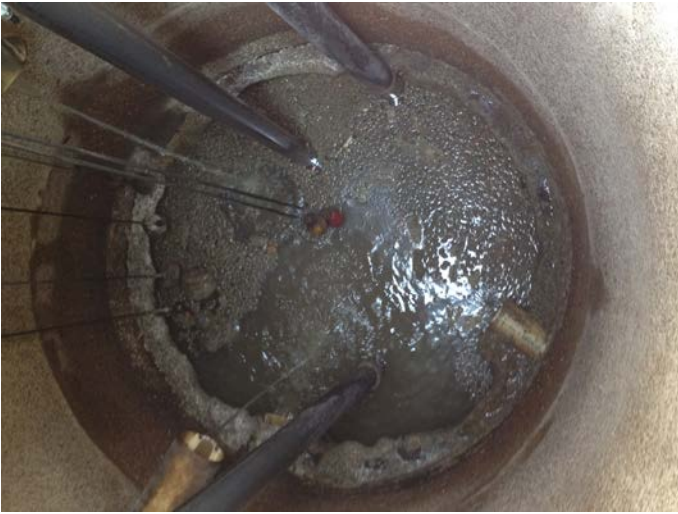
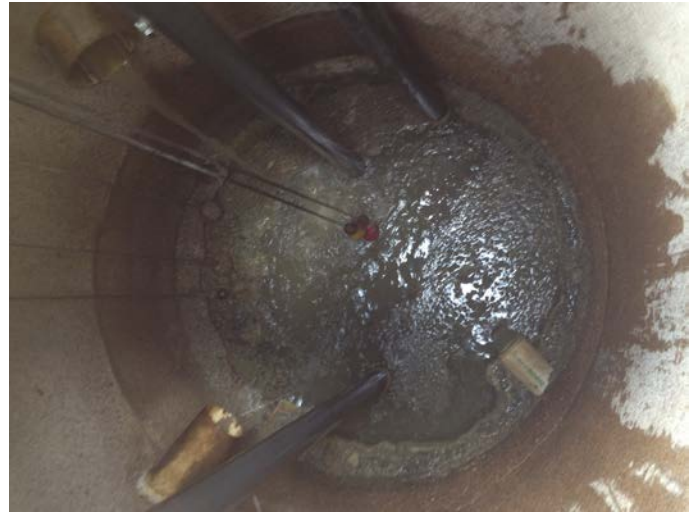
July 9, 2012 and July 19, 2012

The above photos were taken of the wet well at the K Street Lift Station in Somerset, Texas on July 9<sup>th</sup> (left) and July 19<sup>th</sup> (right).

At this point we have been treating the area for 6 and 7 weeks, respectively. In these two photos, the lips around the pipes are gone and we can begin to see that there is an incoming line directly under the pipe on the left hand corner at water level. In the second photo the lip around the wall on the top of the photo has fallen off and is floating near the lower group of floats.

Dosage: 5 gallons per week in the lift station.

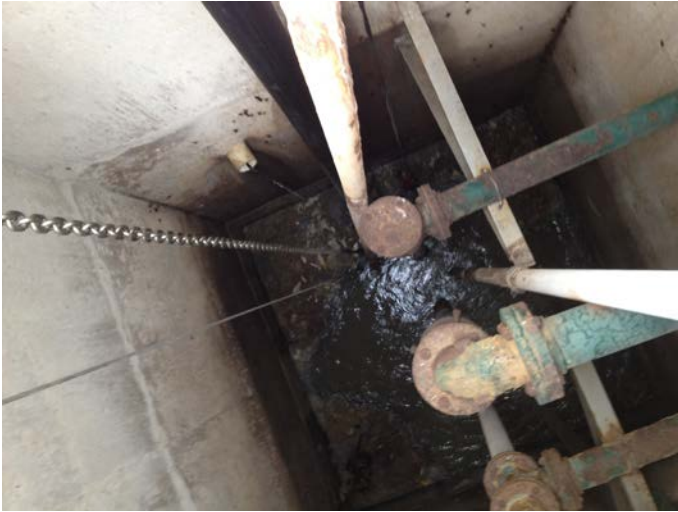
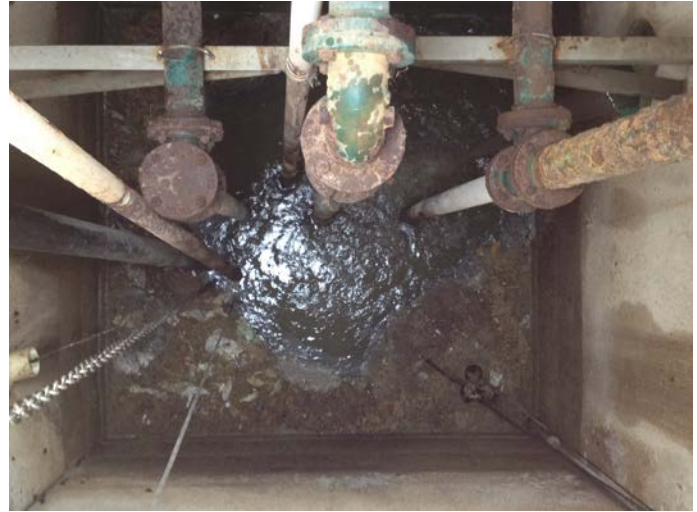
June 21, 2012 and July 9, 2012

The above photos were taken at the Somerset Wastewater Treatment Plant's Master Lift Station in Somerset, Texas on June 21<sup>st</sup> (left) and July 19<sup>th</sup> (right).

This lift station wasn't being treated directly, but it was the nearest downstream lift station, over 2 miles downstream. In the picture on the right you can see that a good portion of the grease has a light brown color and a light fluffy texture. A positive sign that the Micro-Solve is working its way to the plant and the facultative bacteria are beginning to thrive. As a result of a TCEQ inspection, Ricky Carrasco scheduled a vaccing out. Ted's crew and Ricky both confirmed that the lift station typically had a lot more grease and needed to be cleaned out every three months. Ricky also confirmed that 'gum ball' sized grease chunks that he typically fished-out of the clarifier were now only the size of pebbles.

Dosage: 5 gallons per week in the 'K' Street Lift Station that is located 2 miles upstream.

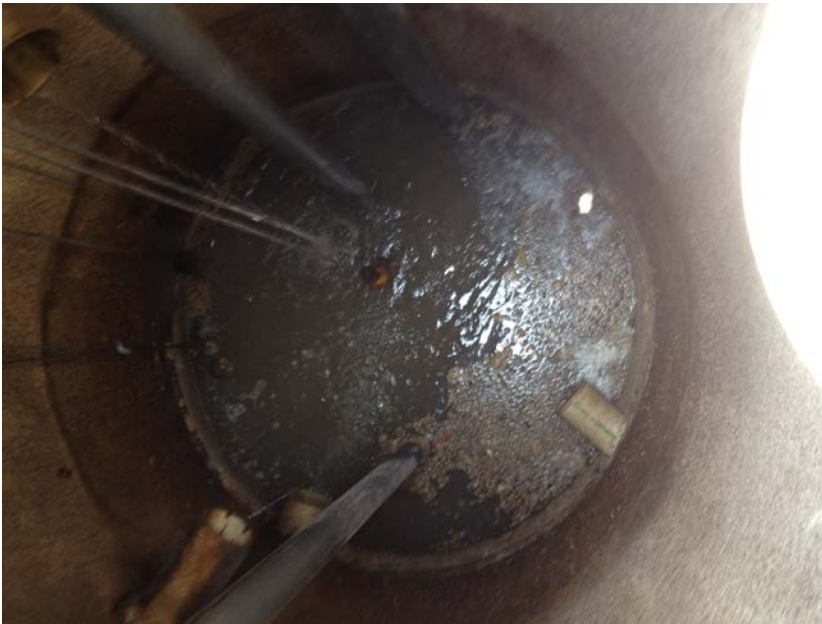
August 23, 2012

The above photo was taken of the wet well at the K Street Lift Station in Somerset, Texas on August 23, 2012.

During the last month of the pilot we noticed that all the pipe-shaped 'logs' of grease that were dislodged from the inside of the submerged pipes were nearly 100% gone. The grease lip around the wall that had previously built up, and was not even able to be removed by the vac truck, is at least 80% - 90% gone. The grease around the incoming pipe is fresh, soft and already partially digested. It has no properties to bind itself to any floats, pumps or pipes and cause issues associated with grease build up.

Mr. Jim Doersam came to visit the lift station and confirmed with Mr. Terry Ploetz that the lift station does typically develop a grease cake across the top and that it typically needs to be vacced-out every three months. Mr. Ploetz cameraed to the downstream collection line and confirmed that none of the grease had resolidified downstream.

Dosage: 3 gallons per week maintenance.
