Documentation for  
Grease and Odor Control Project  
Using:

**PROJECT** – Collection Line Grease Control with Micro-Solve<sup>®</sup>

**CLIENT** – City of Victoria, Texas

**LOCATION** – John Stockbauer Dr. at the Creekstone Ranch Apartments

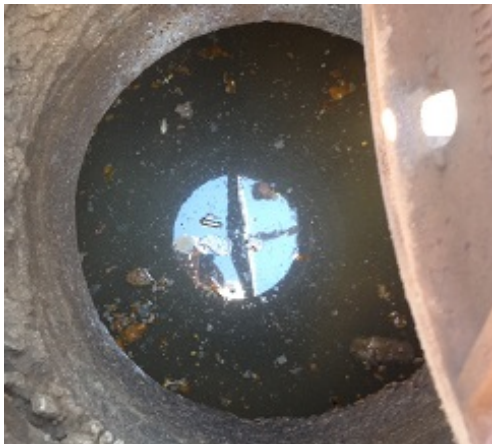
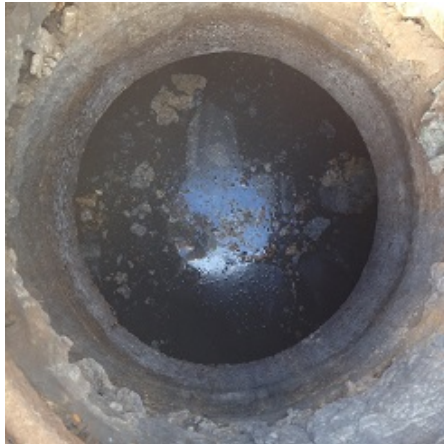
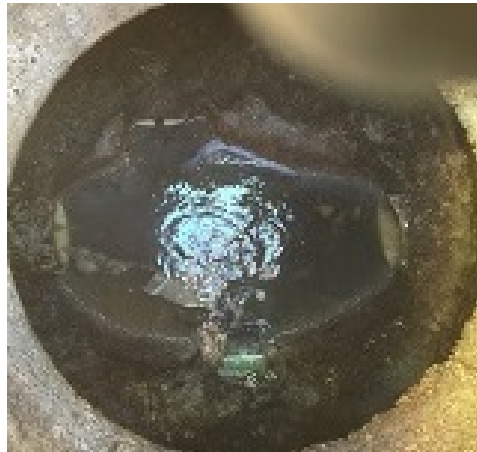
**Creekstone Ranch Manhole:** December 19, 2015

The collection line that runs along John Stockbauer Dr. is an 8" line that has two 90° turns within the first 1000ft. After the second 90° turn, the line runs approximately one mile to Hallettsville Lift Station, which is said to receive half of the city before feeding the WWTP. The point of application itself is in a close proximity to the actual beginning of the line, which gives us a nice controlled area for this initial project.

**Issues:** The primary issue with this line is its tendency to choke. After discussing the area with Juan Robles, there is a general consensus that the line has a "Belly" between the point of application and the second manhole, located next to Halepaska's Bakery. He confirmed the line had been videoed.

**Progress:** The photos above were taken on 10/1, 11/5 and 12/19 respectively. Early on in the project, there was a "choke" and even on one visit the area was surcharged due to large pieces of freed up grease, acting as a baffle slowing up flows (see following page). Since the flow was being restricted on the 11/5 photo, you can get a glimpse of the digestion process at work with the change of color and texture of the grease in the area. At the point of the last photo (12/19), it had been two months since the area had been surcharged. In my opinion a major indication Micro-Solve® is working well at this location.

**Current Dosage:** Maintenance Dosage of 5 gallons every other week.

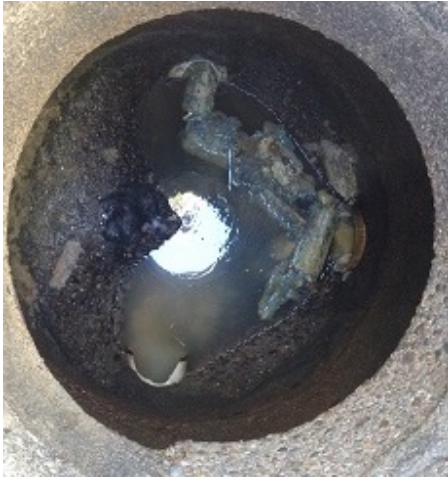
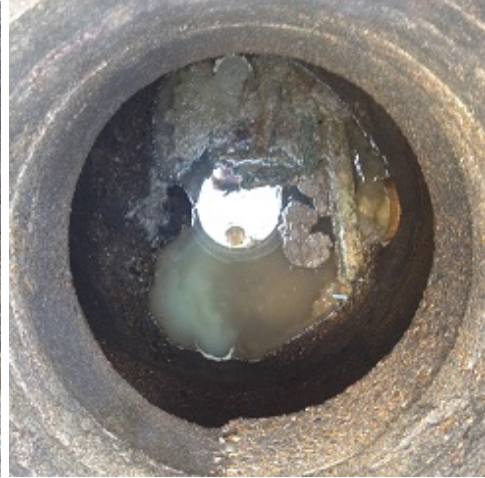
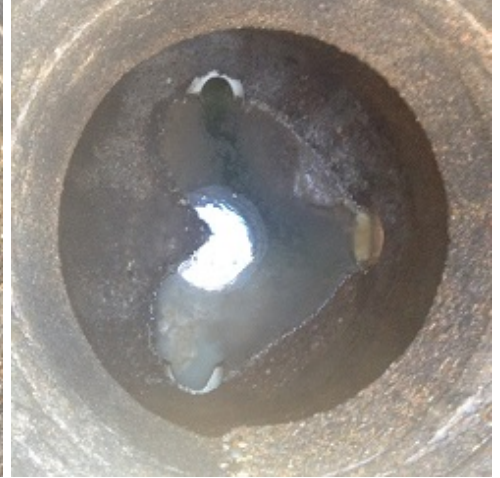
### Manhole at Halepaska's Bakery:

**Progress:** These three photos are of the manhole next to the bakery and were taken on 10/15, 11/5 and 12/3. As you can see in the first two photos (10/15 and 11/5), Micro-Solve® is not only breaking down the large logs of grease, but also all the fresh grease coming in from the bakery, at the bottom of the photo.

**Current Dosage:** None at this location.

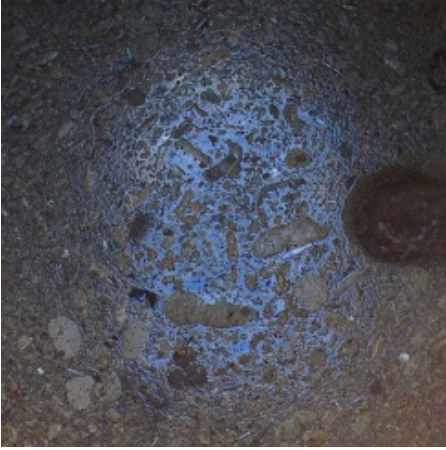
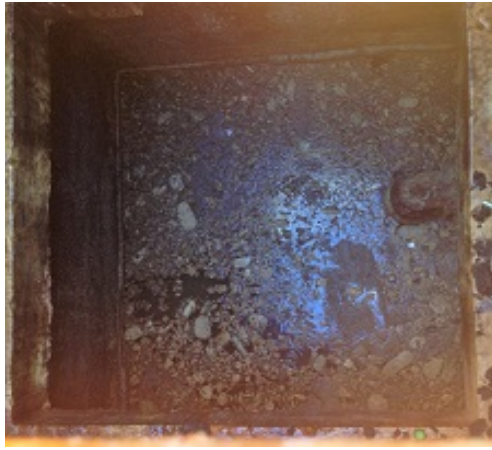
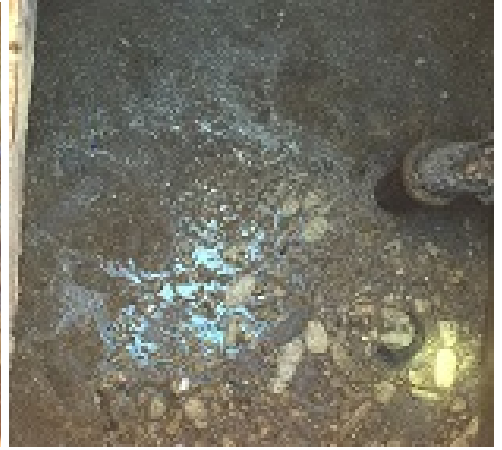
### Hallettsville Lift Station:

**Progress:** As we pointed out in our initial report, we've been seeing an increased amount of large chunks of grease entering the area. The point that should be made is that the texture of the grease is changing, the mass of those large chunks is starting to disperse and those large chunks are now able to be digested by the increased populations of facultative microorganisms. At this point we recommend to agitate this wet well or add a mixing unit to help speed up the process a bit, more oxygen increase the appetites of all those naturally occurring bacteria. Since we're having some effect on this area, with consistent use and some agitation, I predict continued improvement in this wet well in the near future. Micro-Solve® is NOT a quick-fix product. Micro-Solve® is a bioremediation tool.

**Current Dosage:** None at this location.
