Project Documentation for  
Odor and Grease Control Project

**PROJECT** - Grease Control in Somerset, TX

**CLIENT** – San Antonio River Authority

**LOCATION** – K Street Lift Station

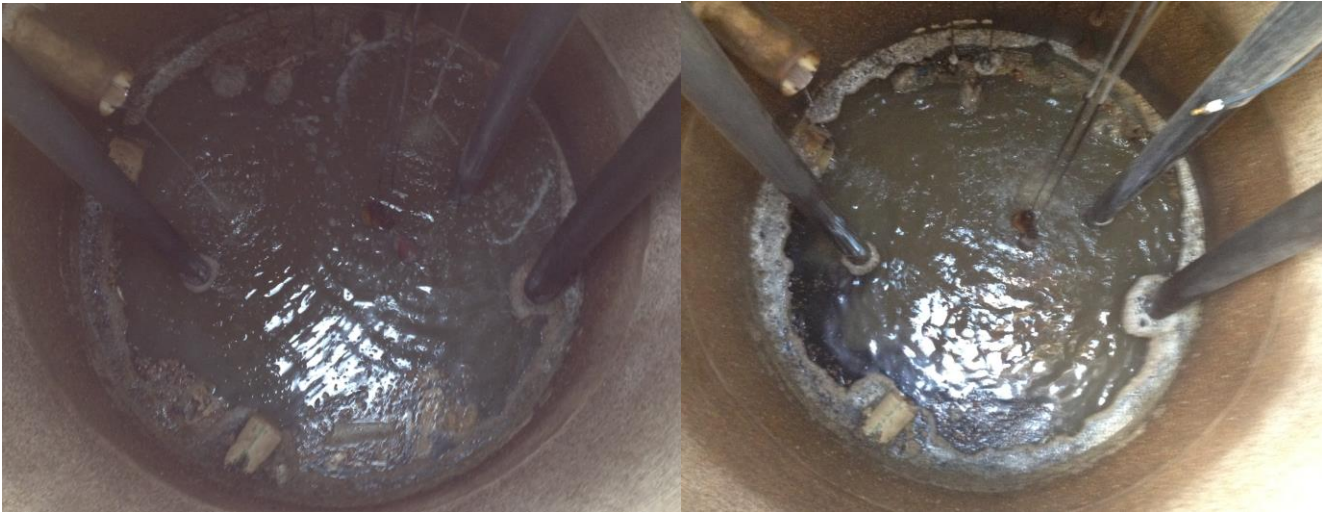
#### **May 30, 2012 – First Application**

The above photos were taken of the wet well at the K Street Lift Station in Somerset, Texas on May 2<sup>nd</sup> (left) and May 30<sup>th</sup> (right).

Even though the lift station appears to be vacced out regularly, in both of these photos we can visually see the calcified grease that has collected around the walls, floats and pipes that are in contact with the water. In most experiences if there is a calcified build-up that is visible on or above the water line, then there will also be a build up of debris and sludge below the surface of the water.

Issues: This area is being fed a large amount of grease from an upstream community center. The lift station is said to need vaccing every 3 months. The lift station is having issues setting off alarms, which in turn is requiring an on-call employee to tend to the emergency. Mr. Ploetz confirmed that grease is getting caught in the pump and is the primary cause of the issue.

Dosage: 5 gallons per week in the lift station. 5 gallons per week in the downstream collection line.

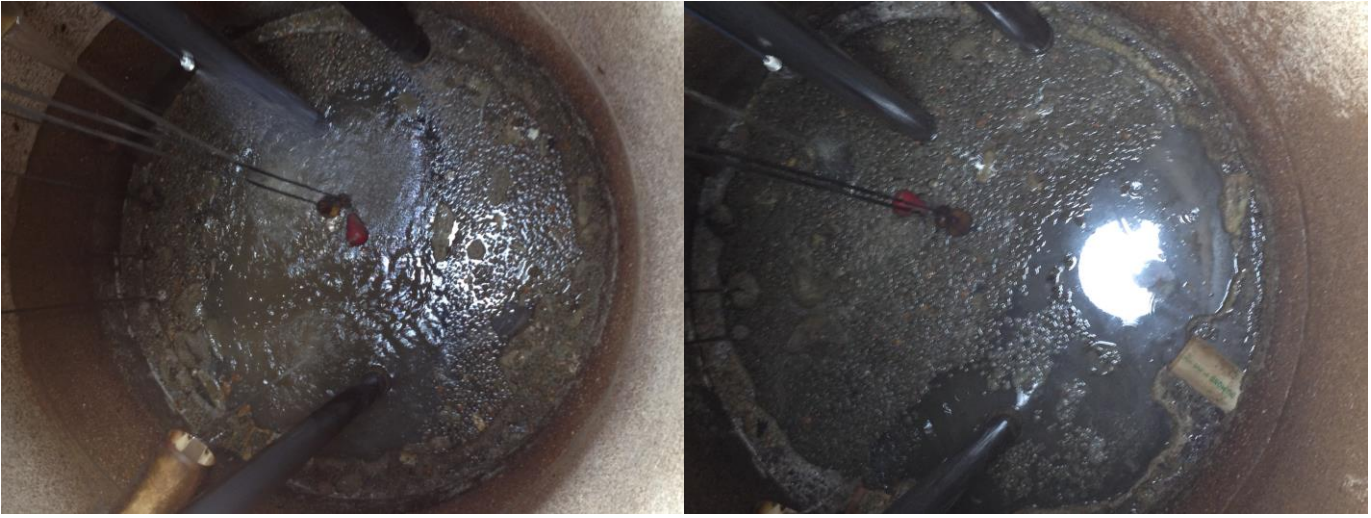
June 14, 2013 and June 21, 2013

The above photos were taken of the wet well at the K Street Lift Station in Somerset, Texas on June 14<sup>th</sup> (left) and June 21<sup>st</sup> (right).

At this point we have been treating the area for 2 and 3 weeks and it can be seen that there is a large amount of grease chunks that are starting to appear on the surface. Also, the lip around the wall is beginning to develop large craters that are now holding water. Micro-Solve has begun to erode the calcified lip around the wet well and we can also notice that the fresh grease that is entering the area is being digested by the facultative aerobes and anaerobes. The floats are staying clean and you can see from one week to the next the incoming pipe on the lower right hand corner becomes visible.

Dosage: 5 gallons per week in the lift station. 5 gallons per week in the downstream collection line.

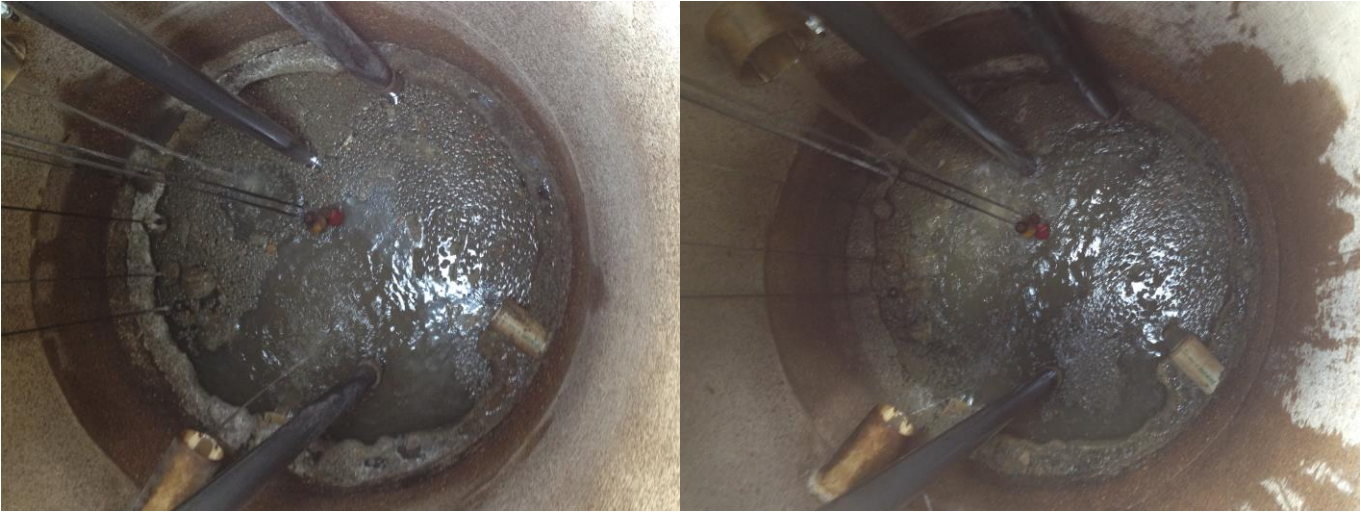
July 9, 2012 and July 19, 2012

The above photos were taken of the wet well at the K Street Lift Station in Somerset, Texas on July 9<sup>th</sup> (left) and July 19<sup>th</sup> (right).

At this point we have been treating the area for 6 and 7 weeks, respectively. In these two photos, the lips around the pipes are gone and we can begin to see that there is an incoming line directly under the pipe on the left hand corner at water level. In the second photo the lip around the wall on the top of the photo has fallen off and is floating near the lower group of floats.

Dosage: 5 gallons per week in the lift station.

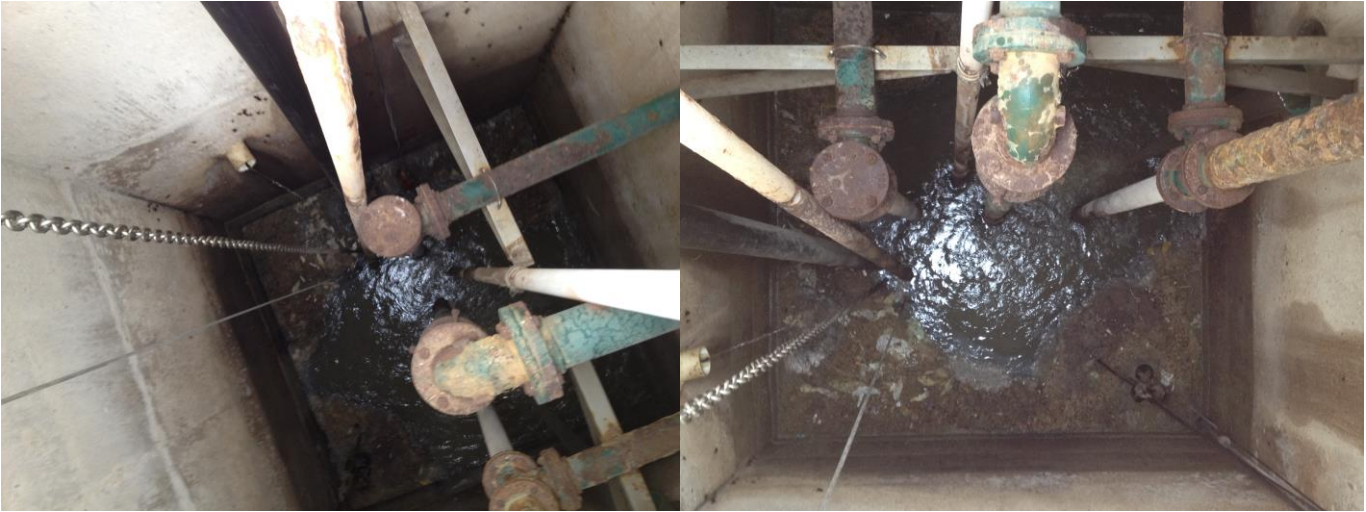
June 21, 2012 and July 9, 2012

The above photos were taken at the Somerset Wastewater Treatment Plant's Master Lift Station in Somerset, Texas on June 21<sup>st</sup> (left) and July 19<sup>th</sup> (right).

This lift station wasn't being treated directly, but it was the nearest downstream lift station, over 2 miles downstream. In the picture on the right you can see that a good portion of the grease has a light brown color and a light fluffy texture. A positive sign that the Micro-Solve is working its way to the plant and the facultative bacteria are beginning to thrive. As a result of a TCEQ inspection, Ricky Carrasco scheduled a vaccing out. Ted's crew and Ricky both confirmed that the lift station typically had a lot more grease and needed to be cleaned out every three months. Ricky also confirmed that 'gum ball' sized grease chunks that he typically fished-out of the clarifier were now only the size of pebbles.

Dosage: 5 gallons per week in the 'K' Street Lift Station that is located 2 miles upstream.

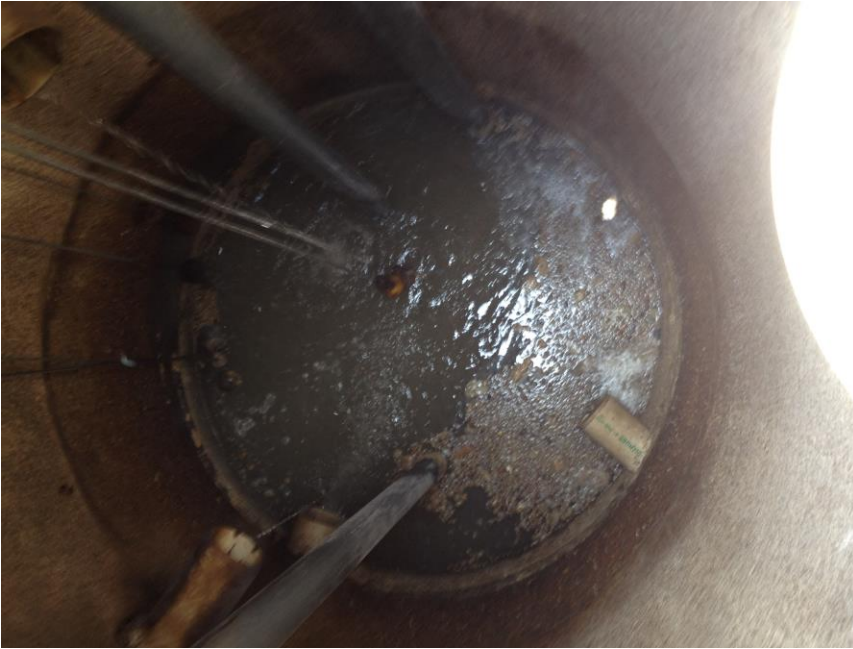
August 23, 2013

The above photo was taken of the wet well at the K Street Lift Station in Somerset, Texas on August 23, 2013.

During the last month of the pilot we noticed that all the pipe-shaped 'logs' of grease that were dislodged from the inside of the submerged pipes were nearly 100% gone. The grease lip around the wall that had previously built up, and was not even able to be removed by the vactor truck, is at least 80% - 90% gone. The grease around the incoming pipe is fresh, soft and already partially digested. It has no properties to bind itself to any floats, pumps or pipes and cause issues associated with grease build up.

Mr. Jim Doersam came to visit the lift station and confirmed with Mr. Terry Ploetz that the lift station does typically develop a grease cake across the top and that it typically needs to be vacced-out every three months. Mr. Ploetz did camera the downstream collection line and confirmed that none of the grease had resolidified downstream.

Dosage: 3 gallons per week maintenance.
