Documentation for  
Completion of Grease and Odor Control Project  
On Collection Line Using:

**Micro-Solve<sup>®</sup>**

**CLIENT** - Severn Trent/MUD 163

**LOCATION** - 8507 Hot Springs Collection line H1-H2-H3-H4-H5-H6-H7-and  
Lift Station # 1 8411 Sunny Ridge Dr. Houston Tx. 77095

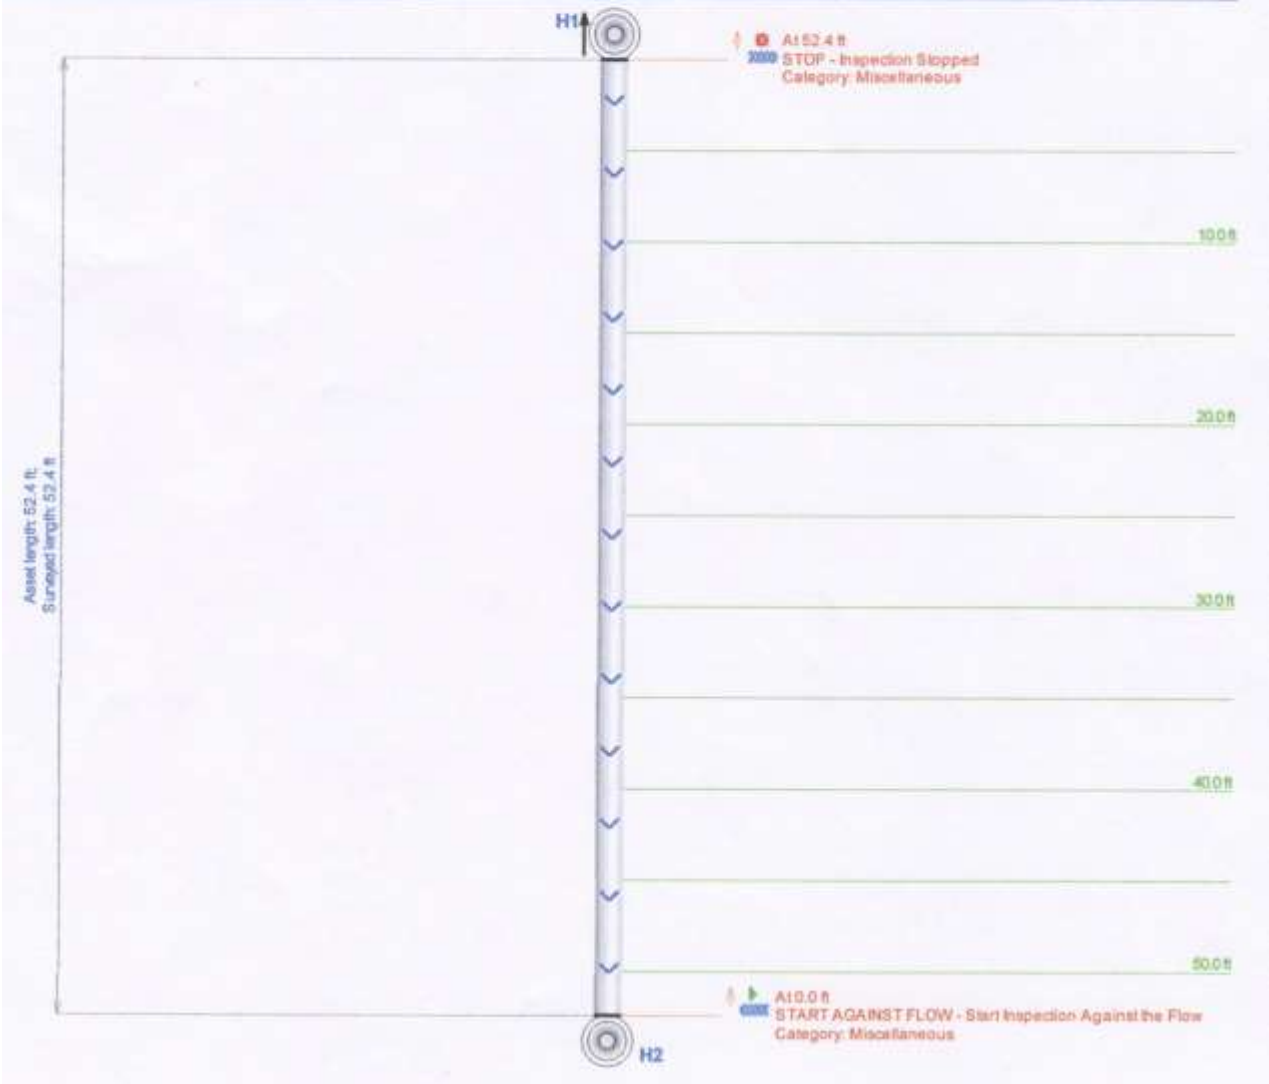
After Micro-Solve® H1 to H2

- H1 to H2: Before and after shows that the camera made it through the line and the line showed no obstructions and no debris build-up.
- H2 to H3: (same) Before and after shows that the camera made it through the line and the line showed no obstructions and no debris build-up.

Project Name: HC163-DIST. AREA	Mainline ID: H1/H2	City: CYPRESS	Address: 8506 HOT SPRINGS DR.
Start date/time: 10/29/2015	Pipe width: 6	Pipe height: 8	Pipe type: Other
Direction: UPSTREAM	Surface condition: Garden	Weather: Dry	Comments: LINE DEPTH 92" UP STREAM
Surveyed footage: 52.4	Operator: RICKY JINKS

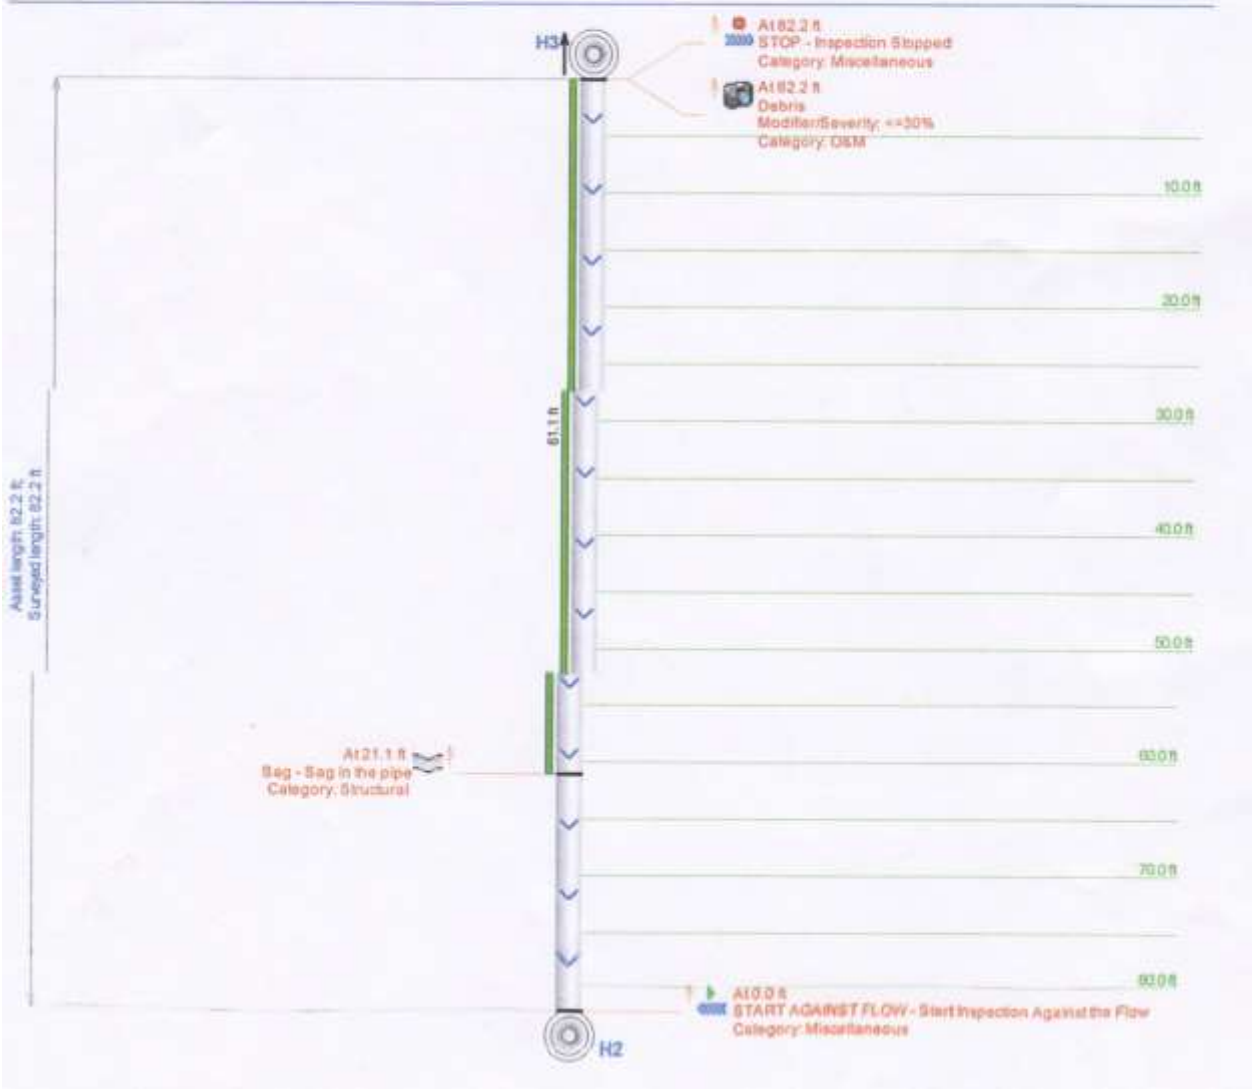
Before Micro-Solve® H2 to H3

Project Name: <b>HC163-8507 HOT SPRINGS DR.</b>		Mainline ID: <b>H3/H2</b>		City: <b>CYPRESS</b>		Address: <b>8502 HOT SPRINGS DR.</b>	
Start date/time: <b>7/31/2015</b>		Pipe width: <b>8</b>	Pipe height: <b>8</b>	Pipe type: <b>Other</b>	Surface condition: <b>Garden</b>	Weather: <b>Dry</b>	
Direction: <b>UPSTREAM</b>		Surveyed footage: <b>82.2</b>		Operator: <b>RICKY JINKS</b>		Comments: <b>LINE DEPTH 144" UP STREAM</b>
