Documentation for
Grease and Odor Control Project
Using:

PROJECT – Collection Line Grease Control with Micro-Solve[®]
CLIENT – City of Victoria, Texas
LOCATION – John Stockbauer Dr. at the Creekstone Ranch Apartments

Re: Final project documentation for grease control using Micro-Solve®, solubilizer, demulsifier and bacteria accelerator.

Creekstone Ranch Manhole: December 19, 2015

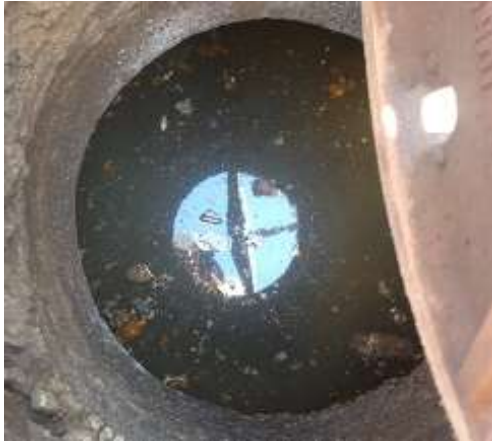
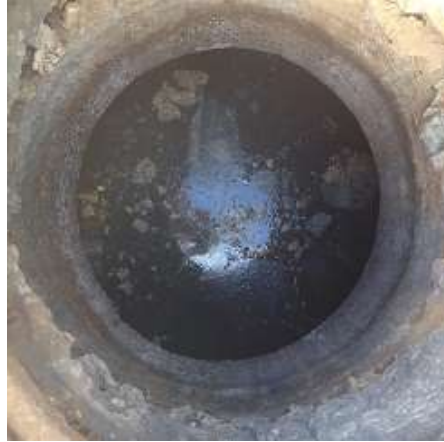
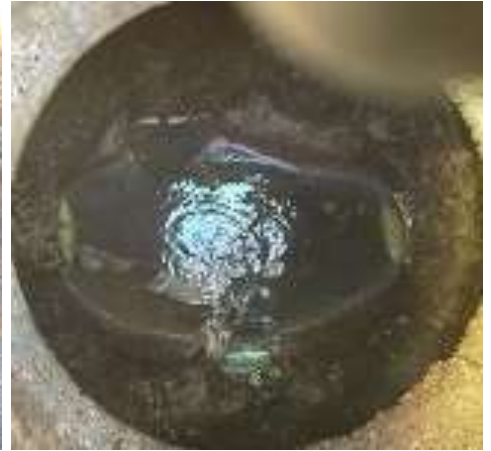
The collection line that runs along John Stockbauer Dr. is an 8" line that has two 90° turns within the first 1000ft. After the second 90° turn, the line runs approximately one mile to Hallettsville Lift Station, which is said to receive half of the city before feeding the WWTP. The point of application itself is in a close proximity to the actual beginning of the line, which gives us a nice controlled area for this initial project.

Issues: The primary issue with this line is its tendency to choke. After discussing the area with Juan Robles, there is a general consensus that the line has a "Belly" between the point of application and the second manhole, located next to Halepaska's Bakery. He confirmed the line had been videoed.

Progress: The photos above were taken on 10/1, 11/5 and 12/19 respectively. Early on in the project, there was a "choke" and even on one visit the area was surcharged due to large pieces of freed up grease, acting as a baffle slowing up flows (see following page). Since the flow was being restricted on the 11/5 photo, you can get a glimpse of the digestion process at work with the change of color and texture of the grease in the area. At the point of the last photo (12/19), it had been two months since the area had been surcharged. In my opinion a major indication Micro-Solve® is working well at this location.

Current Dosage: Maintenance Dosage of 5 gallons every other week.

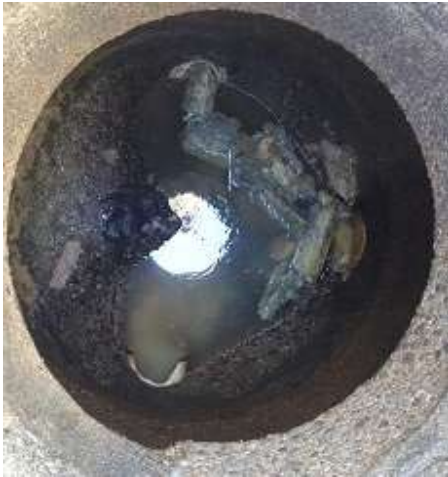
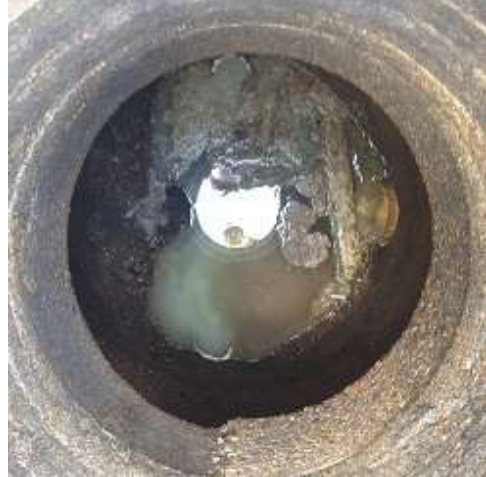
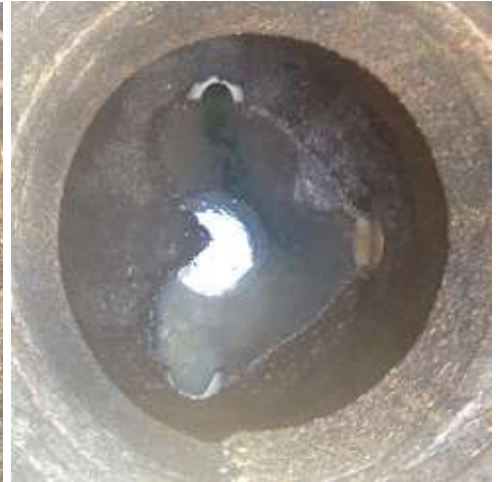
Manhole at Halepaska's Bakery:

Progress: These three photos are of the manhole next to the bakery and were taken on 10/15, 11/5 and 12/3. As you can see in the first two photos (10/15 and 11/5), Micro-Solve® is not only breaking down the large logs of grease, but also all the fresh grease coming in from the bakery, at the bottom of the photo.

Current Dosage: None at this location.

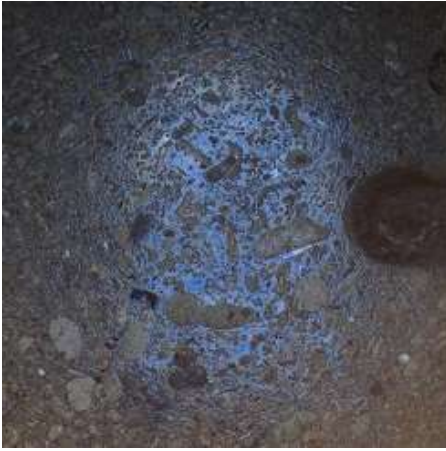
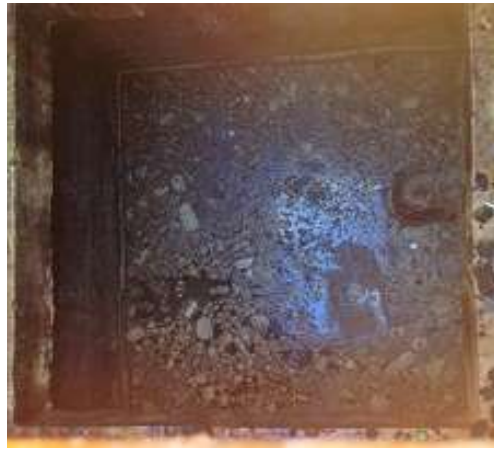
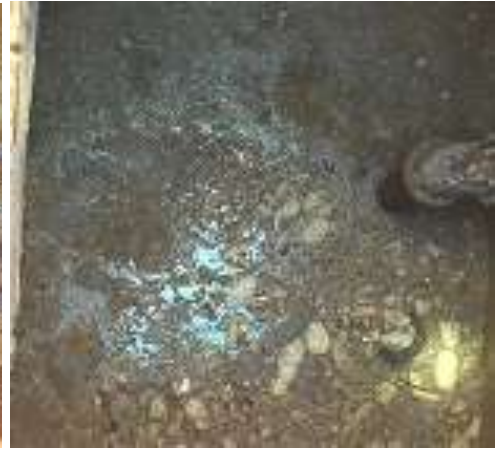
Hallettsville Lift Station:

Progress: As we pointed out in our initial report, we've been seeing an increased amount of large chunks of grease entering the area. The point that should be made is that the texture of the grease is changing, the mass of those large chunks is starting to disperse and those large chunks are now able to be digested by the increased populations of facultative microorganisms. At this point we recommend to agitate this wet well or add a mixing unit to help speed up the process a bit, more oxygen increase the appetites of all those naturally occurring bacteria. Since we're having some effect on this area, with consistent use and some agitation, I predict continued improvement in this wet well in the near future. Micro-Solve® is NOT a quick-fix product. Micro-Solve® is a bioremediation tool.

Current Dosage: None at this location.
