Re: Project Documentation for Grease Control Using Micro-Solve® Solubilizer-Demulsifier/Bacteria Accelerator

This report outlines some of the progress of the Micro-Solve® pilot being applied at Lift Station #6, and the added downstream benefits at Lift Stations #7 / Lift Station #8.

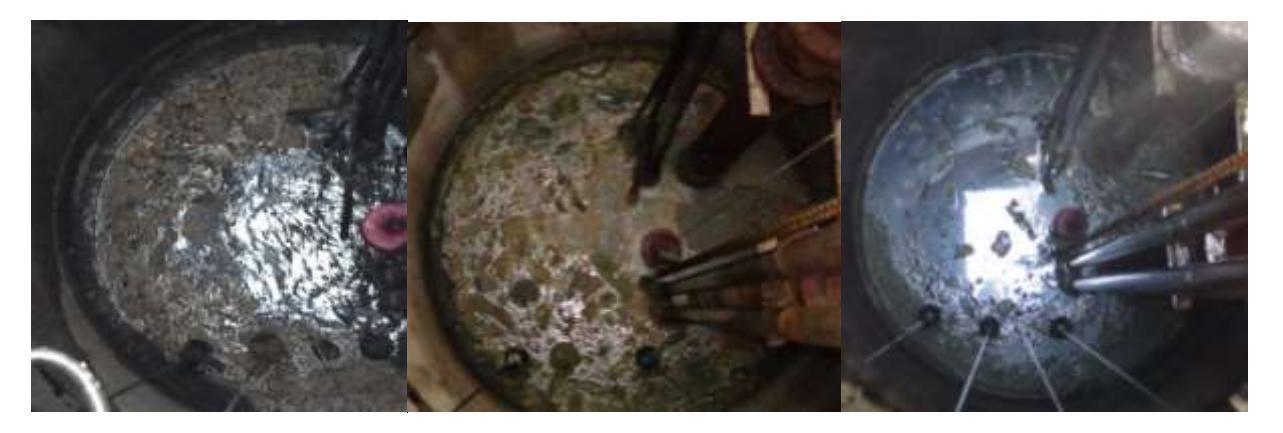
Lift Station #6:

The above photos were taken of the wet well at Lift Station #6 in Lake Dallas, Texas on February 2nd (left), March 8th (Center), and April 30th (right).

Issues: This wet well is located at the most outer lying lift station on this collection line. This wet well is said to have the grease "fished" out of it on a weekly basis. The collection line that was video taped is confirmed to be the incoming line to this area, so we are considering alternating applications from the nearest upstream manhole to the wet well every other week. Mr. Don Johnson confirmed that the large grease chunks were from the incoming line that they had jetted out not too long ago.

The above photos were taken over about a 2 ½ month period of time illustrating the progression of the pilot thus far. We did the final agitation for the pilot and the grease that was in the area was breaking apart in the water, on the walls and floats with just standard water pressure. Notice that the large chunks of grease in the area have dissipated and otherwise been consumed by the facultative bacteria. The grease in the area continues to decrease from week to week and no maintenance has been performed on the station in 10 weeks.

Dosage: 3 gallons per week alternating between the upstream manhole and the wet well at LS #6.

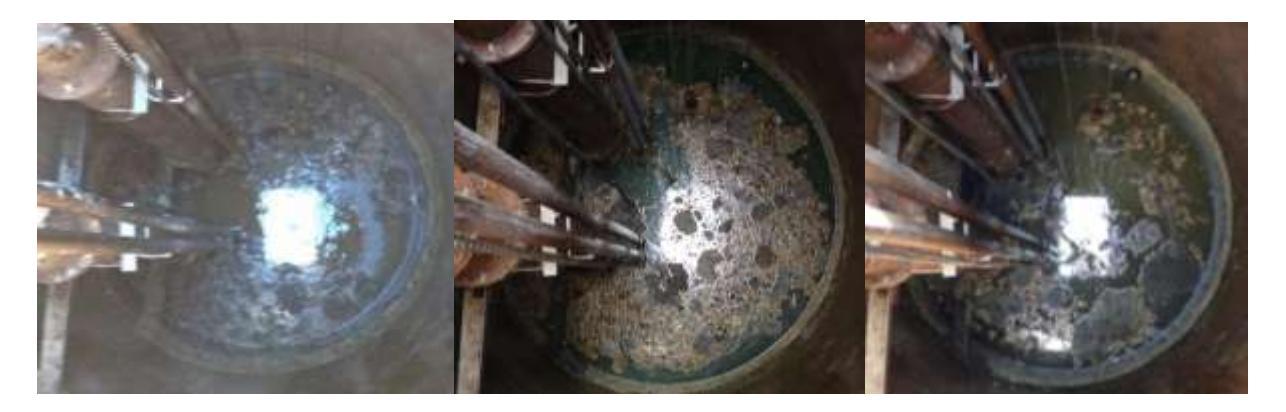
Lift Station #7:

The above photos were taken of the wet well at Lift Station #7 in Lake Dallas, Texas on February 2nd (left) and April 16th (Center), and April 30th (right).

Issues: This wet well was previously being cleaned out on a weekly basis.

There has been a significant reduction in solids since the start of the pilot and even from the previous week. Notice almost all of the smaller pieces of grease from the previous weeks have been consumed by the facultative bacteria and the larger pieces of grease that were in the well have started to spread out and dissipate with very little density to the chunks. The grease that remains is very soft/soluble and not causing any problems in the area.

Dosage: Micro-Solve® is not being directly applied at this location.

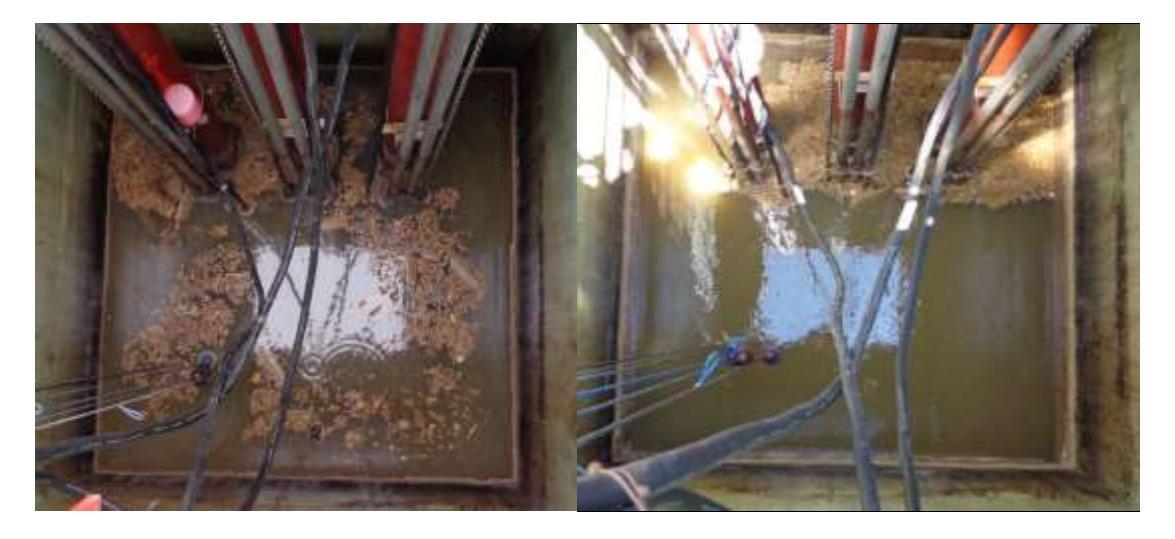
Lift Station #8:

The above photos were taken of the wet well at Lift Station #8 in Lake Dallas, Texas on February 2nd (left) and April 30th (right).

This wet well was previously being cleaned out on a weekly basis. There was previously an odor concern and some calcified grease that was collected around the rim of the well and the pipes leading up through the surface.

This station continues to be maintained at the maintenance dosage applied 2 lift stations upstream. The grease that has entered the station is very small and the larger pieces continue to break down and are consumed by the facultative bacteria. The grease that is in the area is not solidifying or causing any problems and no maintenance has been performed at this location in the past 2 ½ months.

Dosage: Micro-Solve[®] is not being directly applied at this location (Application 2 lift station up stream).
