Documentation for  
grease and odor control project  
using

**PROJECT** - Grease and Odor Control in Port Isabel/South Padre Island, TX

**CLIENT** – Laguna Madre Water District

Re: Project Documentation for Grease and Odor Control Using Micro-Solve® Solubilizer-Demulsifier/Bacteria Accelerator

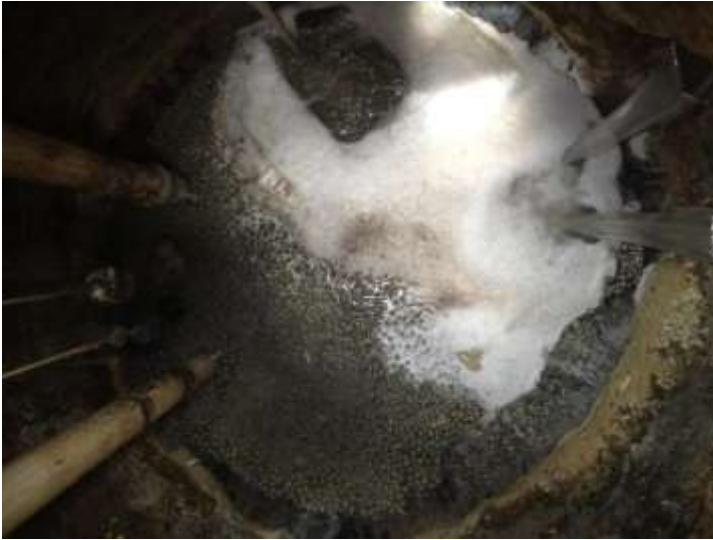
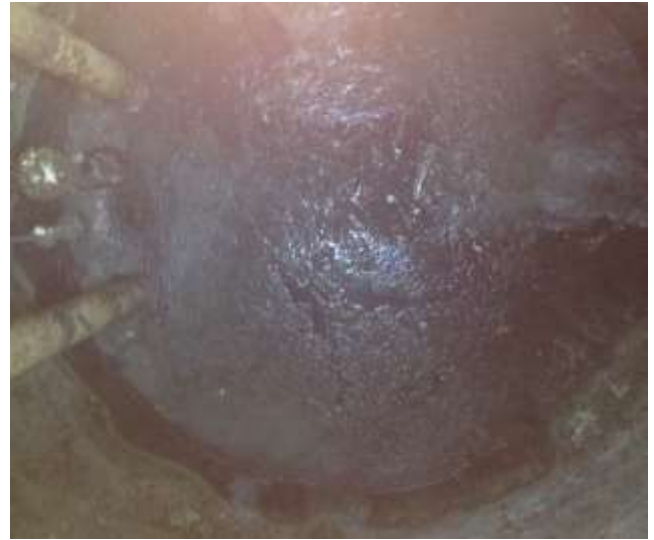
### Lift Station #15:

Issues: This Lift Station is located on Yturria Street in Port Isabel and is being fed primarily by tourism industry. With multiple Tex-Mex restaurants, an Italian restaurant, Burger Grill, Lift Station #14 and a laundrymat feeding the area, an abundance of grease topped with detergents was forcing the crew to vac this wet well out at least once every two months. And as we have seen in many similar situations, this type of industry mixed with South Texas heat was creating a dangerous level of H<sub>2</sub>S (Hydrogen Sulfide).

By using Micro-Solve® to keep the grease from building up in the wet well, LMWD has been able to manage the downstream odor as well. Looking at the foam in the picture above (left), we can assume that there is an excess of bacteria killing detergents entering the well. By bio-remediating the grease in this well, we are able to get to the root of the problem by way of cleaning up the environment where corrosive gasses breed.

**The above photo on the right shows a significant decrease in foam and grease from the previous visit. With a lot of the tourist industry slowing for the winter months the dosage can be reduced until the early spring.**

Currently the dosage is at 5 gallons per week and the drum is 1/3 full.

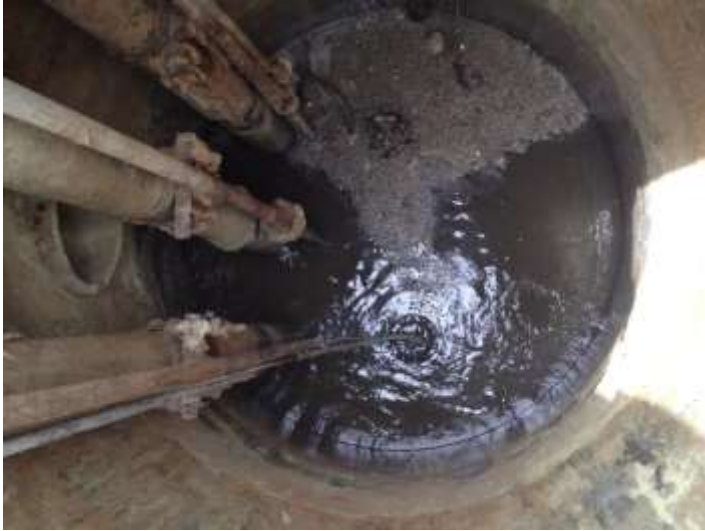
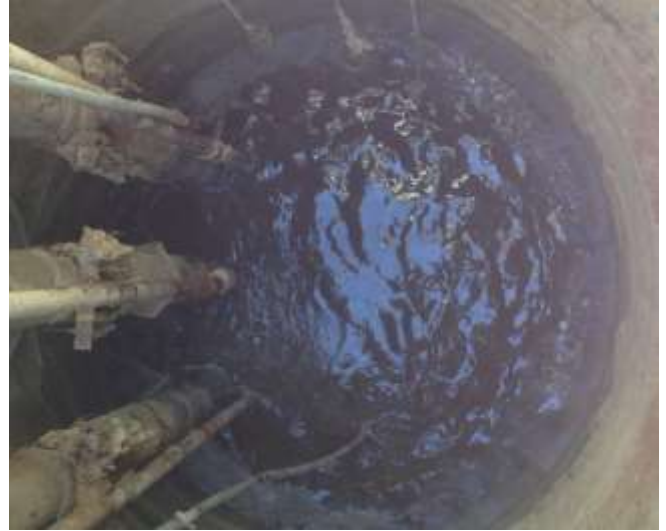
### Lift Station #16:

Issues: This Lift Station is located on South Shore Blvd. and is fed by LS#6, LS#24 and LS#17. The industries feeding this area include Garriga Elementary School, a Shrimp House, a Fish House, residential and all of this discharges directly to LS#11. Previously this wet well had a serious build up of H<sub>2</sub>S gasses and needed to be pumped down on a weekly basis. Tavo and his crew are literally able to identify when the Micro-Solve® drum is empty at LS#15 by the smell of this wet well.

There is currently not any odor at the lift station and the photo on the right, taken November 5<sup>th</sup> shows a continued reduction in solids.

There is not any Micro-Solve® being fed at LS#16.

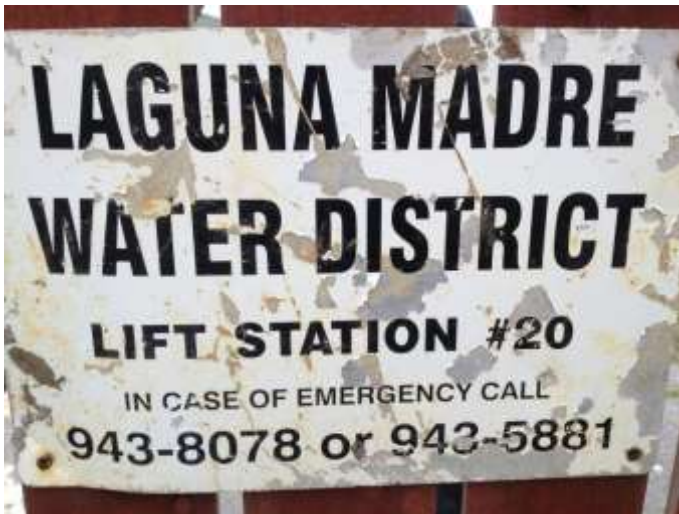
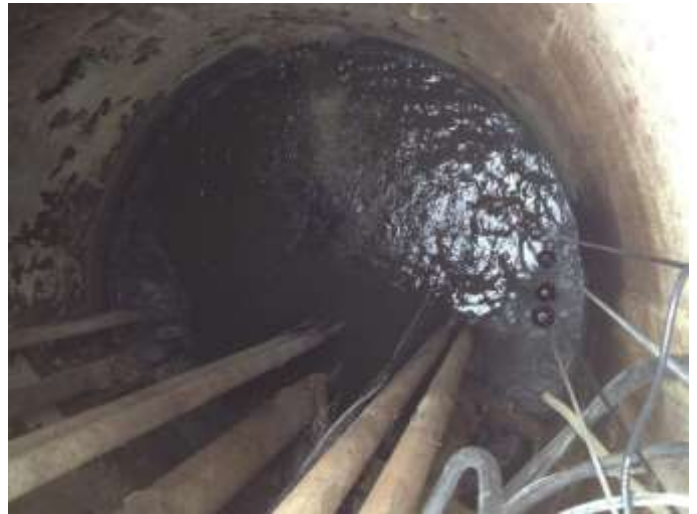
### Lift Station #20:

Issues: This Lift Station is located at E. Dolphin Street on South Padre Island and is fed by Tom and Jerry's Restaurant, The Brewery Restaurant, as well as a number of hotels and condominiums along the Gulf side of the Island. This line discharges to a 12" line that runs directly to Lift Station #19. Originally there was Grease collecting and causing floats to malfunction and the discharge line was supplying LS#19 with an abundance of Hydrogen Sulfide.

This location has been controlling the solids in the wet well and the gasses that were contributing to the odor downstream. As we move into some of the cooler months, I would like to recommend that the dosage be decreased. Per our previous reports, we can monitor this location on a "peak" vs. "non-peak" season dosage rate.

Currently this drum is empty.

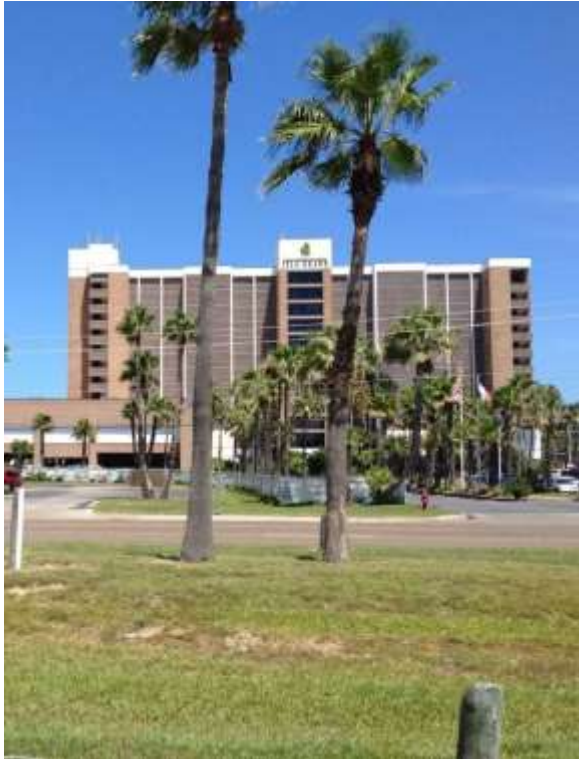
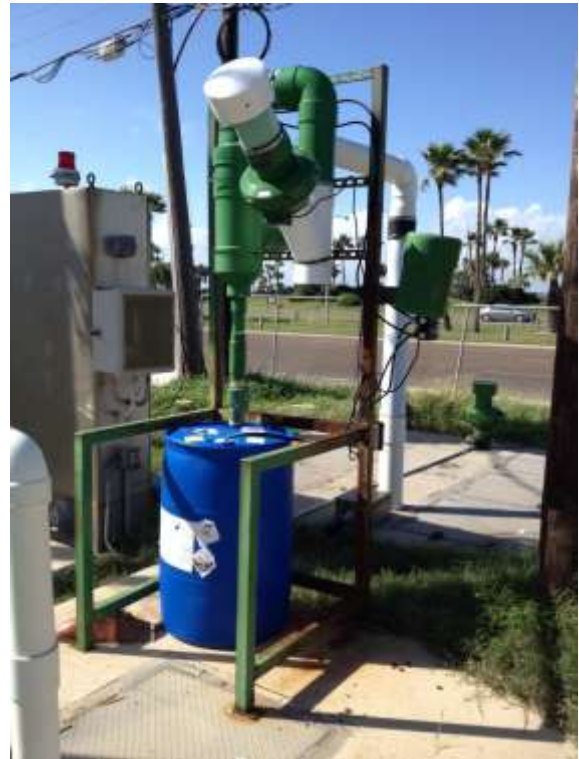
## Lift Station #19:

Issues: This Lift Station is located on Padre Blvd on South Padre Island, nestled between the Boulevard, Isla Grand Resort and a strip center. This area is fed by Lift Station #20, #22, Isla Grand Resort, Saida Towers and the Sapphire Hotel, and then discharges to a 12" line that feeds the WWTP. Previously this area was receiving Odor Complaints in the winter from the shopping center and in the summer when the winds come from the southeast it would blow odor along the walkways were tourist pedestrians pass by.

To decrease the gasses in the system, LMWD is feeding Micro-Solve® at LS#20 and to eliminate the odor complaints there is an Odor-Solve filter unit on the vent. Even though there are several cracks and crevices in this well this system has totally eliminated odor complaints in the area. Currently Lift Station #19 is going through some modifications, so we'll keep observing the area for changes.

Currently there is not any Micro-Solve being fed at this location.

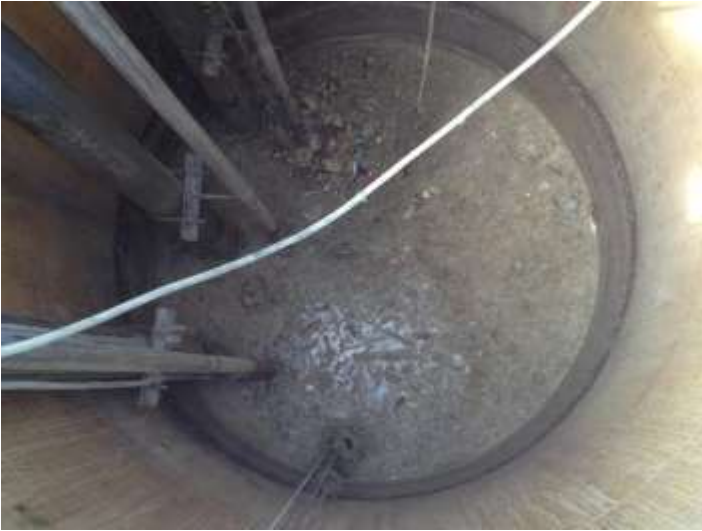
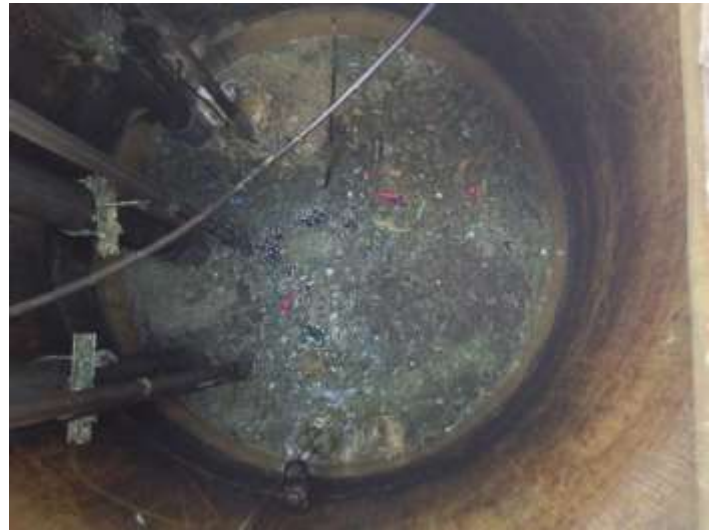
### Lift Station #3:

Issues: This Lift Station is primarily being fed by residential and is said to develop a grease cake from 10" to 12" this and needs to be vacced out every 4 months. This wet well had a medium odor and was a major contributor to a strong odor being released at Lift Station #4.

*At this point all the grease has a light fluffy texture and isn't causing any interference with the functioning of the floats. The log sized chunks of grease are nothing more than mush and the Odor in this wet well has subsided significantly.*

*Currently the dosage is at 6 gallons per week.*

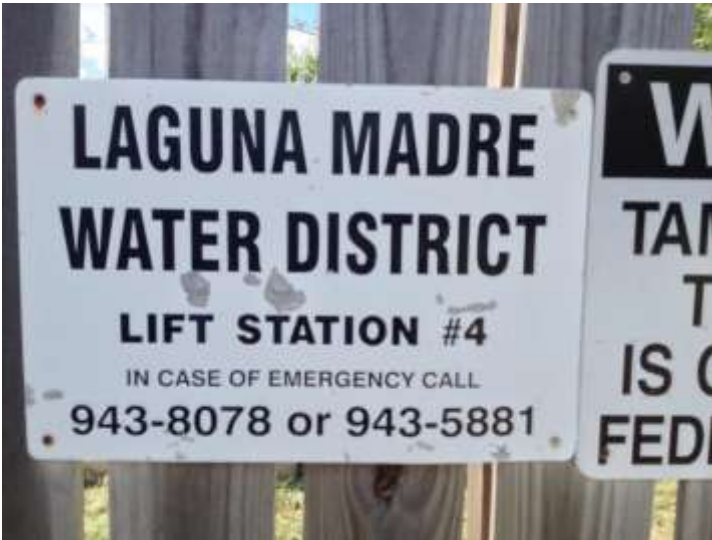
### Lift Station #4:

Issues: This Lift Station is located on the bend on Washington Street and is fed primarily by residential (Laguna Heights), Lift Station #3 and Port Isabel High School. The hydrogen sulfide level in this area was high (700-900 ppm).

The area upstream has been treated all summer long with only one drum of Micro-Solve® and not only are the grease issues diminishing at LS#3, but the odor at LS#4 is very minimal. These two locations have been directed back to the long force main feeding LS#11. This coupled with the LS#10 location is believed to be helping with the gasses being released at the Maintenance Warehouse. We'll keep observing the progress and we should be able to confirm that as the weather warms up in the late spring.

Currently there is not any Micro-Solve being fed at this location.

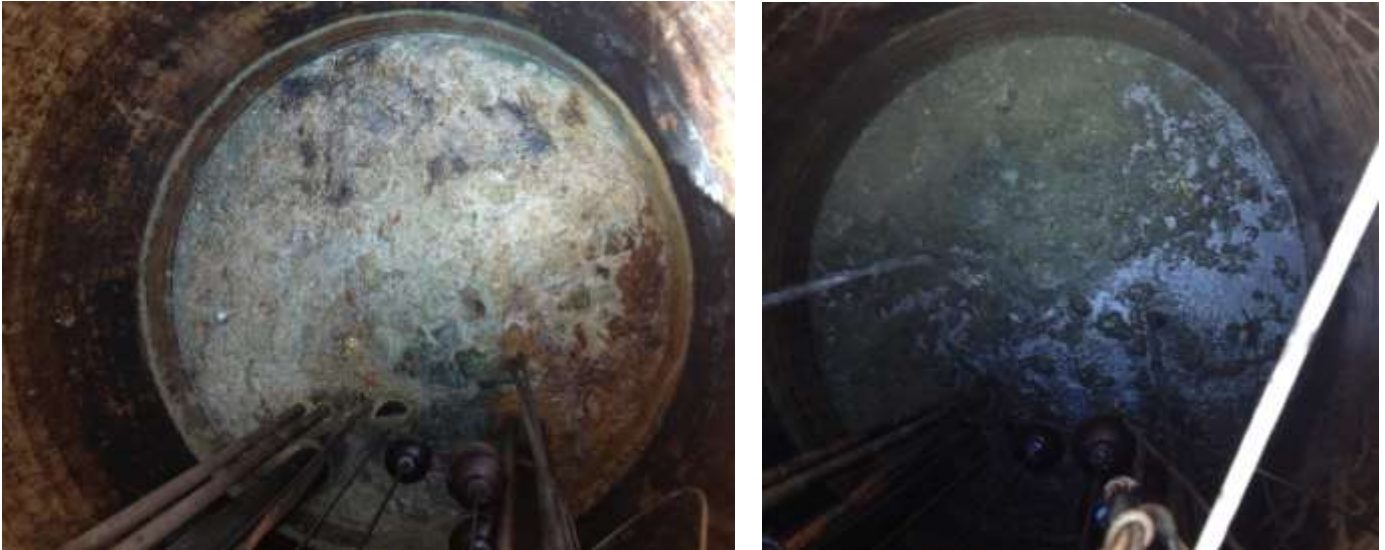
### Lift Station #10:

Issues: This Lift Station is located on State Park Rd. 100 and is fed by a ½ mile long 8" line coming from Beacon Bay a nearby residential community. This wet well discharges in to a 2.5 – 3 mile long force main that leads directly to the master lift station. Previously this wet well would build up with 10"-12" of grease every week. The pumps at this lift station have a small capacity and previously had a difficult time handling the solids.

Since this location has been treated the area only being vacced-out once every three months. The above photo (left), taken on November 5<sup>th</sup> is a drastic improvement from three months ago. Make no mistake about it; this lift station is taking on a lot of fats, oil and grease. Micro-Solve® is keeping the floats clean, eliminating callouts and frequent vaccing.

Currently the dosage is 4 gallons per week and the drum is over half full.

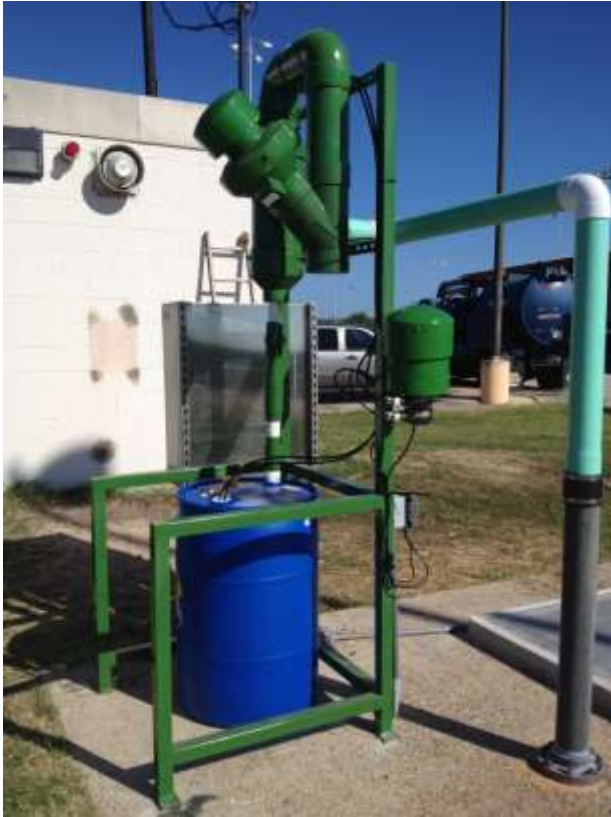
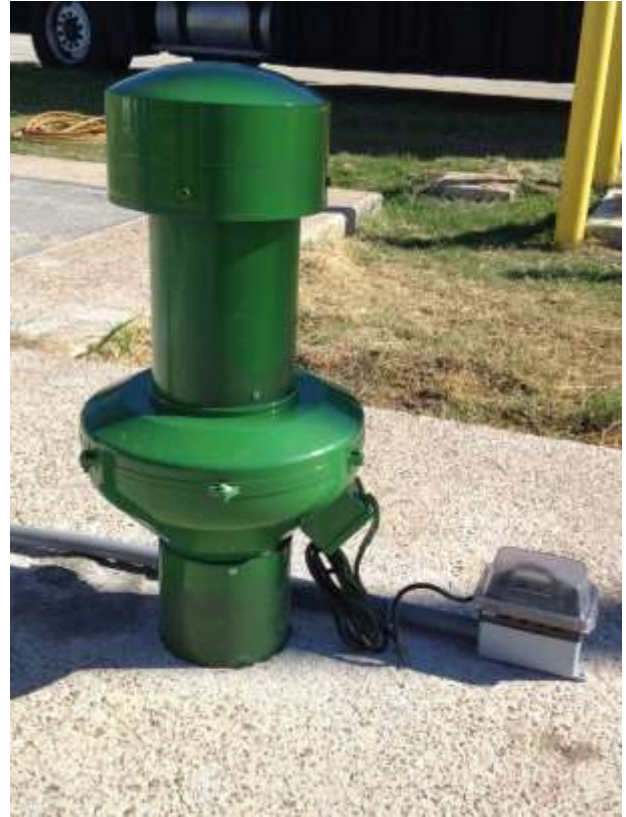
**Lift Station #11:** November 5, 2013

Issues: This Lift Station is located on the bend on Woodys Ln between the Maintenance Warehouse and Wal-Mart. The hydrogen sulfide coming from this area was not only corroding the collection system from the inside-out, but the high level of gas was also creating a significant number of odor complaints coming from Wal-Mart.

With two distant Micro-Solve® application points 3 miles upstream, Lift Stations #3 and Lift Station #10, a percentage of the gas has been reduced. That coupled with the Odor-Solve filter unit at Lift Station #11 the odor complaints have stopped. There are still some cracks and crevices where gasses are escaping, but there has been a huge improvement at an economically reasonable investment. During my visit there was a pump being maintained, so with those hatches open it was difficult to locate where exactly gasses might be escaping.

Currently there is not any Micro-Solve being fed at this location.
