Documentation for
grease and odor control project
using

PROJECT - Grease and Odor Control in Port Isabel/South Padre Island, TX

CLIENT – Laguna Madre Water District

Re: Project Documentation for Grease and Odor Control Using Micro-Solve® Solubilizer-Demulsifier/Bacteria Accelerator

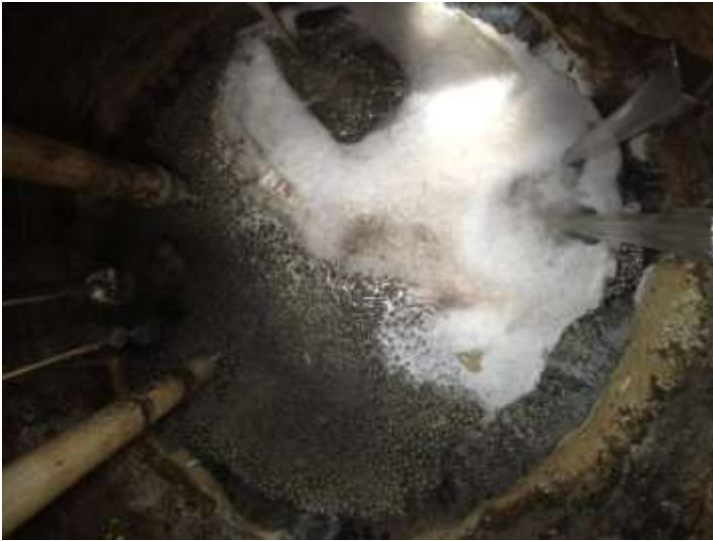
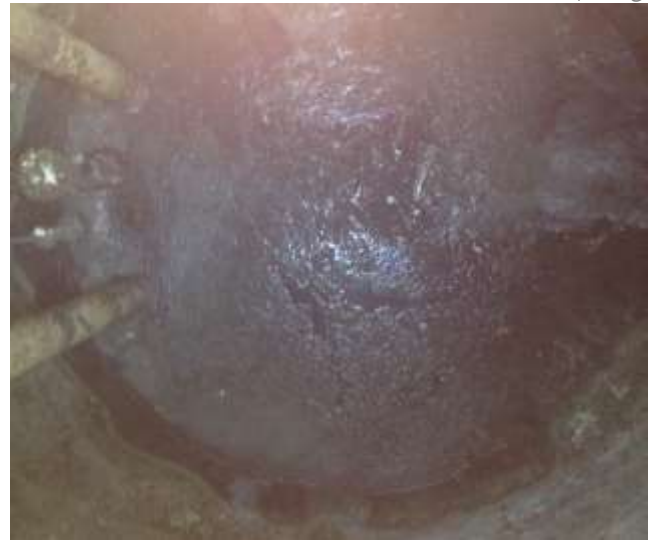
Lift Station #15:

This Lift Station is located on Yturria Street in Port Isabel and is being fed primarily by tourism industry. With multiple Tex-Mex restaurants, an Italian restaurant, Burger Grill, Lift Station #14 and a laundromat feeding the area, an abundance of grease topped with detergents was forcing the crew to vac this wet well out at least once every two months. And as we have seen in many similar situations, this type of industry mixed with South Texas heat was creating a dangerous level of H₂S (Hydrogen Sulfide).

By using Micro-Solve® to keep the grease from building up in the wet well, LMWD has been able to manage the downstream odor as well. Looking at the foam in the

picture above (left), we can assume that there is an excess of bacteria killing detergents entering the well. By bio-remediating the grease in this well, we are able to get to the root of the problem by way of cleaning up the environment where corrosive gasses breed.

The above photo on the right shows a significant decrease in foam and grease from the previous visit. With a lot of the tourist industry slowing for the winter months the dosage can be reduced until the early spring.

Currently the dosage is at 5 gallons per week and the drum is 1/3 full.

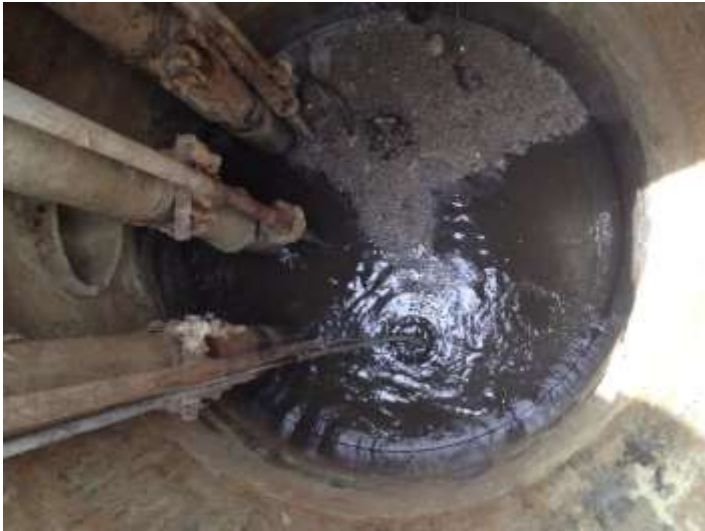
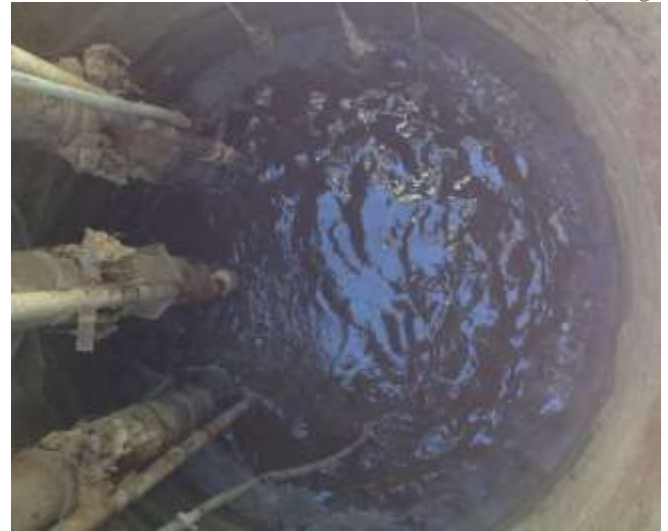
Lift Station #16:

Issues: This Lift Station is located on South Shore Blvd. and is fed by LS#6, LS#24 and LS#17. The industries feeding this area include Garriga Elementary School, a Shrimp House, a Fish House, residential and all of this discharges directly to LS#11. Previously this wet well had a serious build up of H₂S gasses and needed to be pumped down on a weekly basis. Tavo and his crew are literally able to identify when the Micro-Solve® drum is empty at LS#15 by the smell of this wet well.

There is currently not any odor at the lift station and the photo on the right, taken November 5th shows a continued reduction in solids. There is not any Micro-Solve® being fed at LS#16.

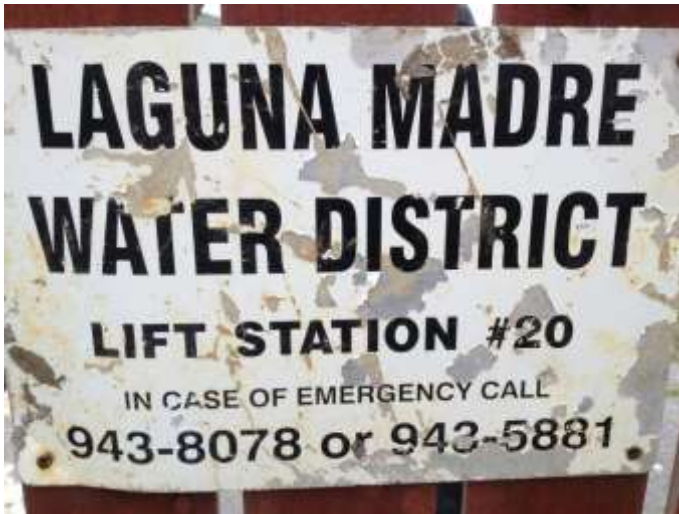
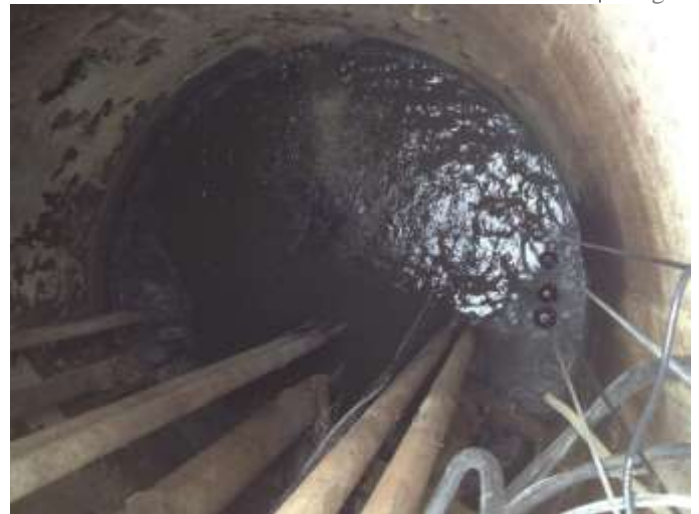
Lift Station #20:

This Lift Station is located at E. Dolphin Street on South Padre Island and is fed by Tom and Jerry's Restaurant, The Brewery Restaurant, as well as a number of hotels and condominiums along the Gulf side of the Island. This line discharges to a 12" line that runs directly to Lift Station #19. Originally there was grease collecting and causing floats to malfunction and the discharge line was supplying LS#19 with an abundance of hydrogen sulfide.

This location has been controlling the solids in the wet well and the gasses that were contributing to the odor downstream. As we move into some of the cooler months, I would like to recommend that the dosage be decreased. Per our previous reports, we can monitor this location on a "peak" vs. "non-peak" season dosage rate. Currently this drum is empty.

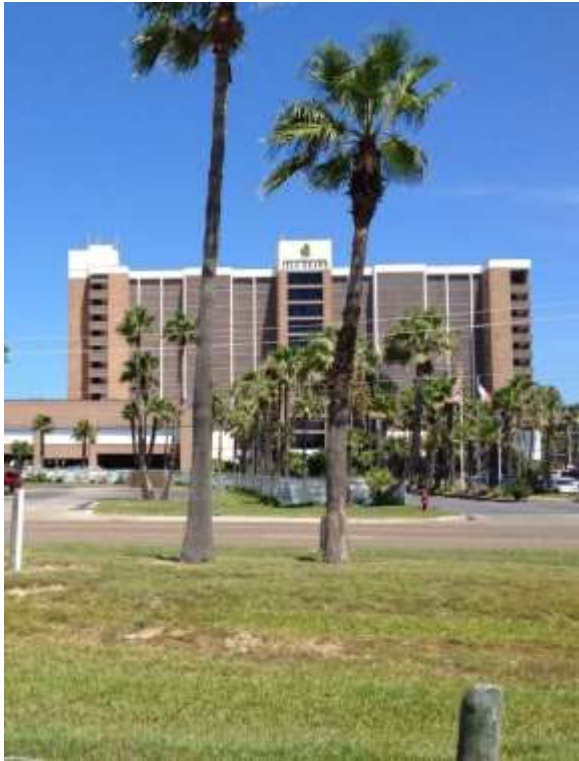
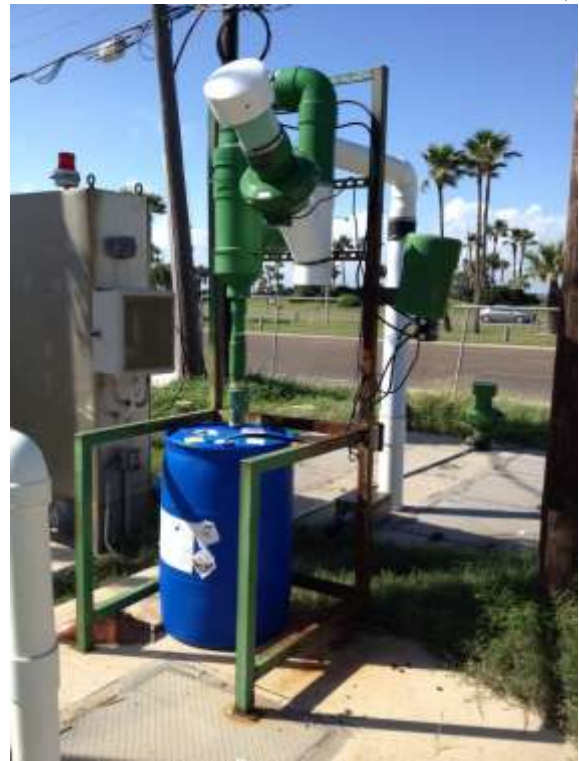
Lift Station #19 November 5, 2013

This Lift Station is located on Padre Blvd on South Padre Island, nestled between the Boulevard, Isla Grand Resort and a strip center. This area is fed by Lift Station #20, #22, Isla Grand Resort, Saida Towers and the Sapphire Hotel, and then discharges to a 12" line that feeds the WWTP. Previously this area was receiving Odor Complaints in the winter from the shopping center and in the summer when the winds come from the southeast it would blow odor along the walkways were tourist pedestrians pass by.

To decrease the gasses in the system, LMWD is feeding Micro-Solve® at LS#20 and to eliminate the odor complaints there is an Odor-Solve filter unit on the vent. Even though there are several cracks and crevices in this well this system has totally eliminated odor complaints in the area. Currently Lift Station #19 is going through some modifications, so we'll keep observing the area for changes.

Currently there is not any Micro-Solve® being fed at this location.

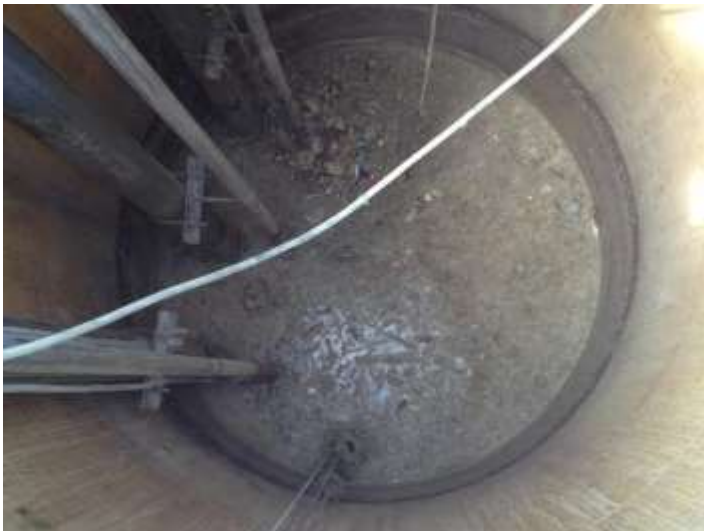
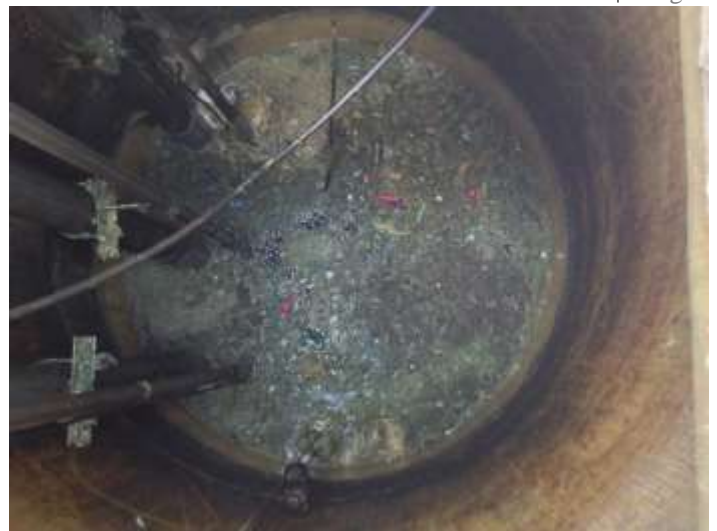
Lift Station #3 November 5, 2013

Issues: This lift station is primarily being fed by residential and is said to develop a grease cake from 10" to 12" this and needs to be vacced out every 4 months. This wet well had a medium odor and was a major contributor to a strong odor being released at Lift Station #4.

At this point all the grease has a light fluffy texture and isn't causing any interference with the functioning of the floats. The log sized chunks of grease are nothing more than mush and the Odor in this wet well has subsided significantly. Currently the dosage is at 6 gallons per week.

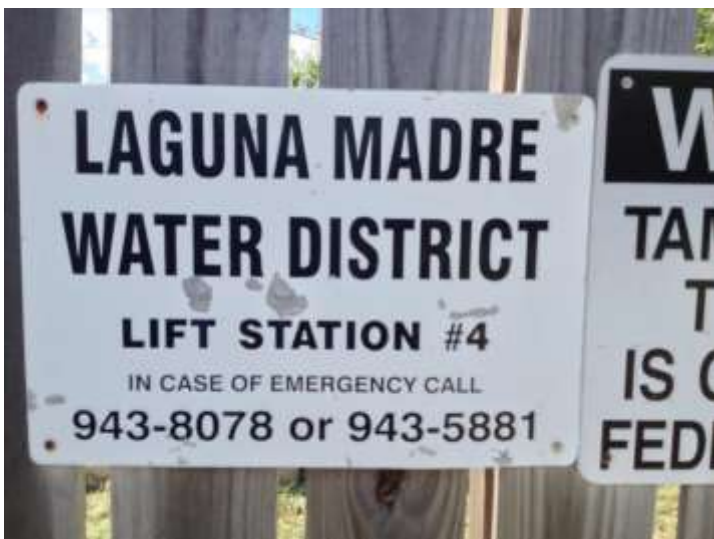
Lift Station #4 November 5, 2013

Issues: This Lift Station is located on the bend on Washington Street and is fed primarily by residential (Laguna Heights), Lift Station #3 and Port Isabel High School. The hydrogen sulfide level in this area was high (700-900 ppm).

The area upstream has been treated all summer long with only one drum of Micro-Solve® and not only are the grease issues diminishing at LS#3, but the odor at LS#4 is very minimal. These two locations have been directed back to the long force main feeding LS#11. This coupled with the LS#10 location is believed to be helping with the gasses being released at the Maintenance Warehouse. We'll keep observing the progress and we should be able to confirm that as the weather warms up in the late spring.

Currently there is not any Micro-Solve® being fed at this location.

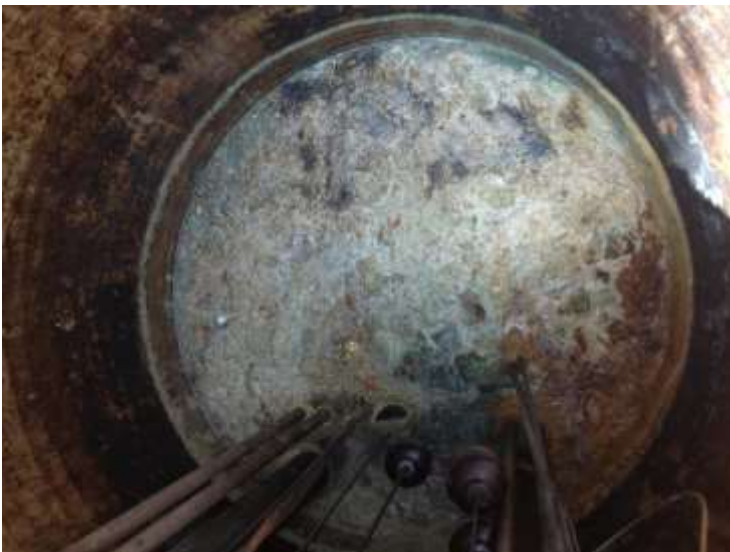
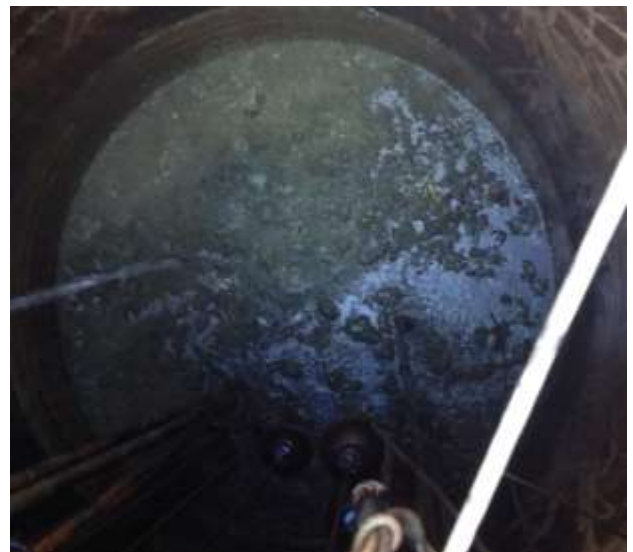
Lift Station #10 November 5, 2013

Issues: This Lift Station is located on State Park Rd. 100 and is fed by a ½ mile long 8" line coming from Beacon Bay a nearby residential community. This wet well discharges in to a 2.5 – 3 mile long force main that leads directly to the master lift station. Previously this wet well would build up with 10"-12" of grease every week. The pumps

at this lift station have a small capacity and previously had a difficult time handling the solids.

Since this location has been treated the area only being vacced-out once every three months. The above photo (left), taken on November 5th is a drastic improvement from three months ago. Make no mistake about it; this lift station is taking on a lot of fats, oil and grease. Micro-Solve® is keeping the floats clean, eliminating callouts and frequent vaccing. Currently the dosage is 4 gallons per week and the drum is over half full.

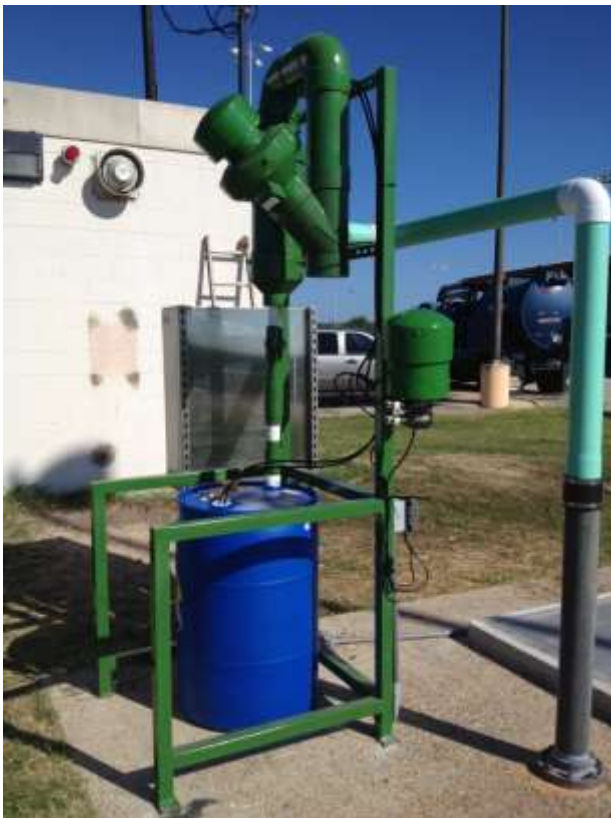
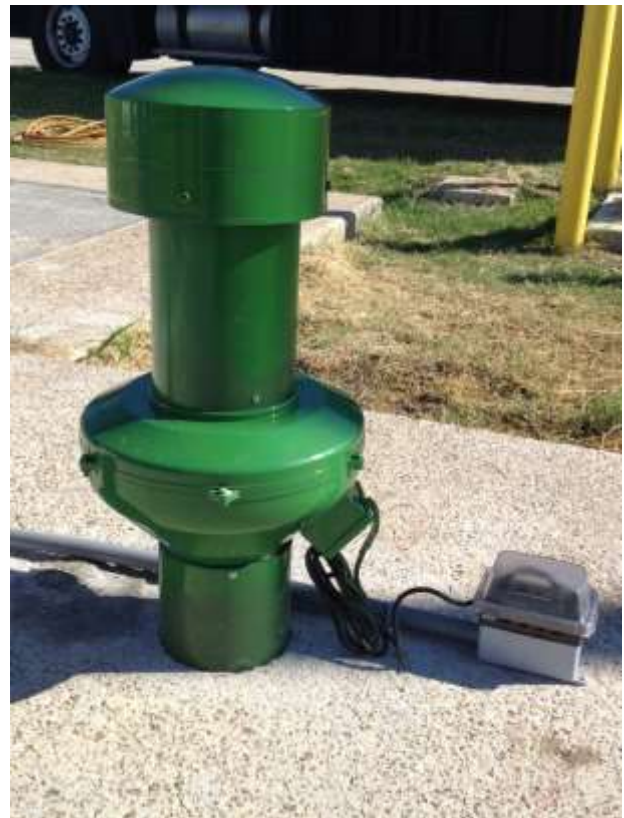
Lift Station #11 November 5, 2013

Issues: This lift station is located on the bend on Woodys Ln between the Maintenance Warehouse and Wal-Mart. The hydrogen sulfide coming from this area was not only corroding the collection system from the inside-out, but the high level of gas was also creating a significant number of odor complaints coming from Wal-Mart.

With two distant Micro-Solve® application points 3 miles upstream, Lift Stations #3 and Lift Station #10, a percentage of the gas has been reduced. That coupled with the Odor-Solve filter unit at Lift Station #11 the odor complaints have stopped. There are still some cracks and crevices where gasses are escaping, but there has been a huge improvement at an economically reasonable investment. During my visit there was a pump being maintained, so with those hatches open it was difficult to locate where exactly gasses might be escaping.

Currently there is not any Micro-Solve® being fed at this location.

As I mentioned before, it sure would be great to get out there and agitate a few of those wet wells. We noticed at several of our other accounts that results being seen are significantly better where the lift stations are being agitated. I do understand your challenges with scheduling the truck, but it is still worth mentioning. Either way, you and LMWD are getting some stellar results. Thanks for all that you guys do.
